Status of the GEM and CSC systems

Elena Kulish on behalf of
the GEM and CSC groups

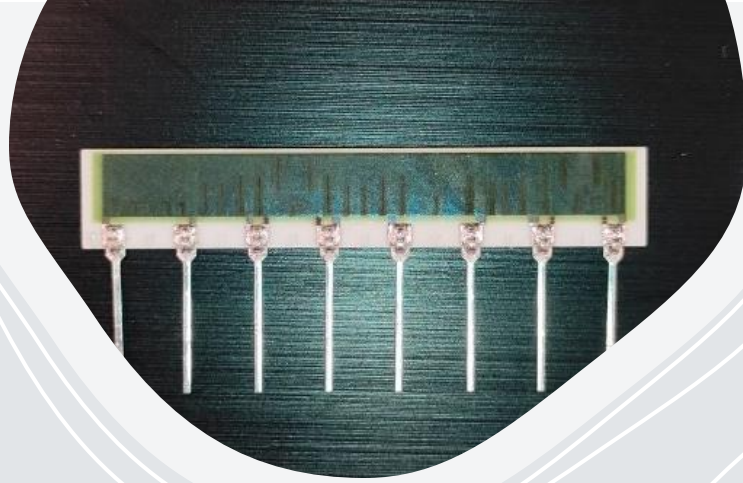
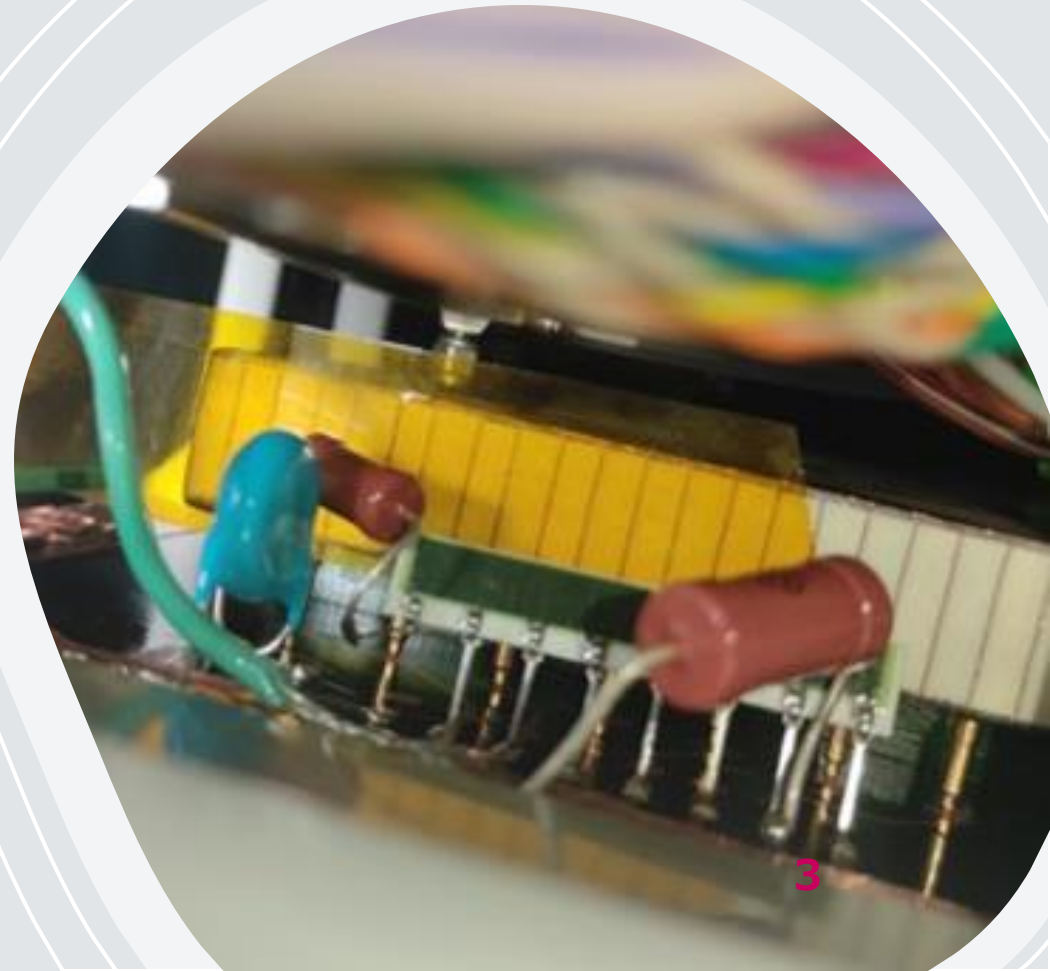
At the end of the Run 8, the detector M15 stopped working normally because the divider leg broke.

The existing divider design is not suitable for repair in the SP-41 magnet. Therefore it was decided to modernize the design of the divider.

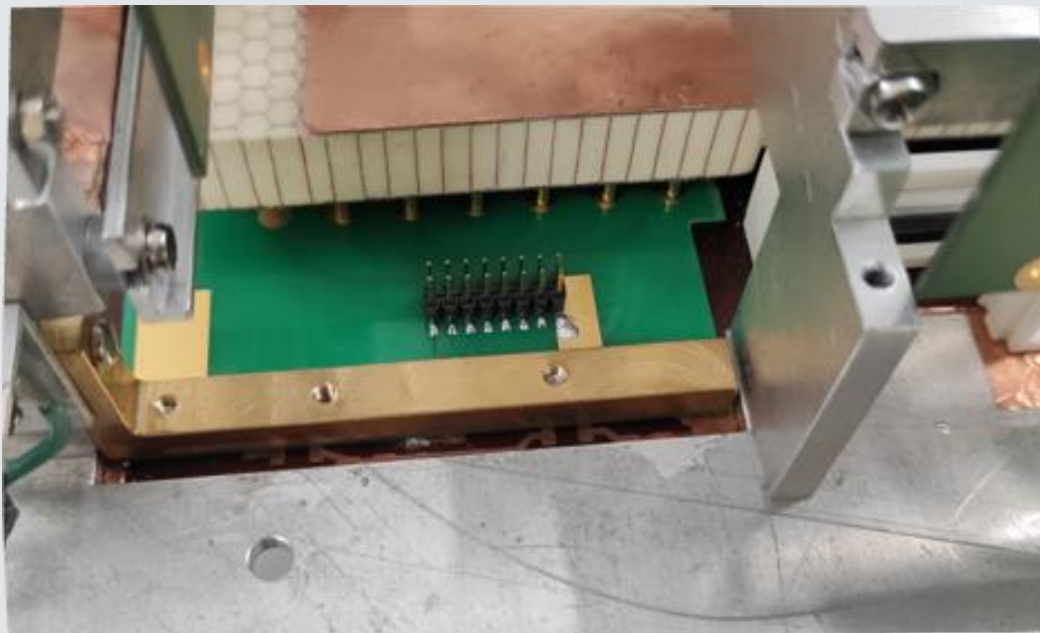
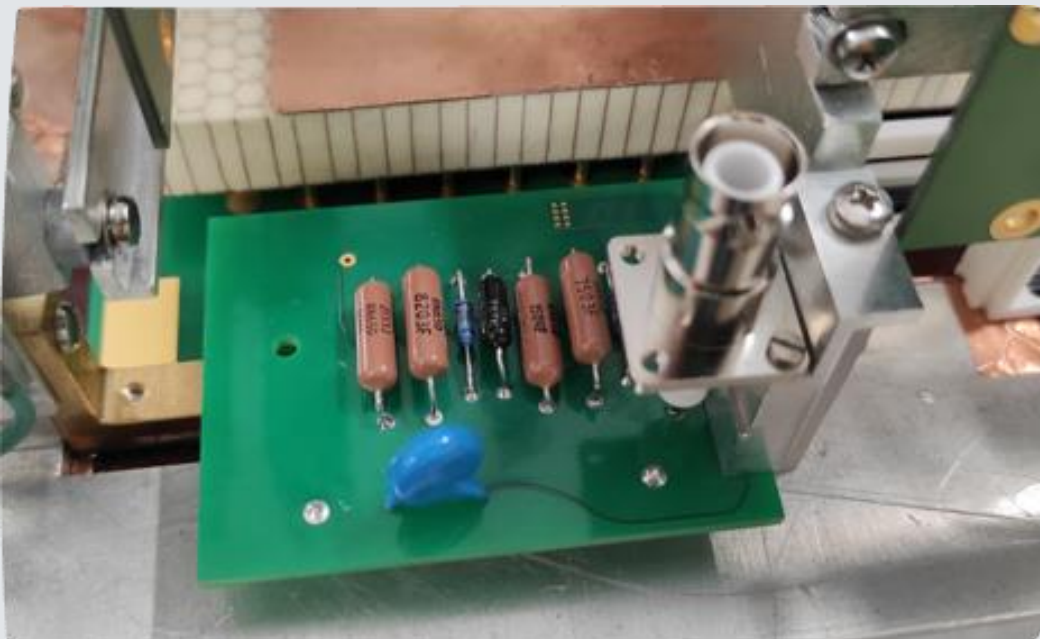
New type high voltage divider

Problems (solved): pins get stuck and do not allow the board to move freely.

New HV divider consists of two boards - stationary and removable, on which there are mating parts of the connector. Removable board contains resistors and a high voltage connector. Stationary board contains traces from the connector to the pads for pins contacts.

Thus, the part with resistors can be removed from detectors and replaced. And also, if necessary, it will be possible to replace resistors and change the parameters of the divider.

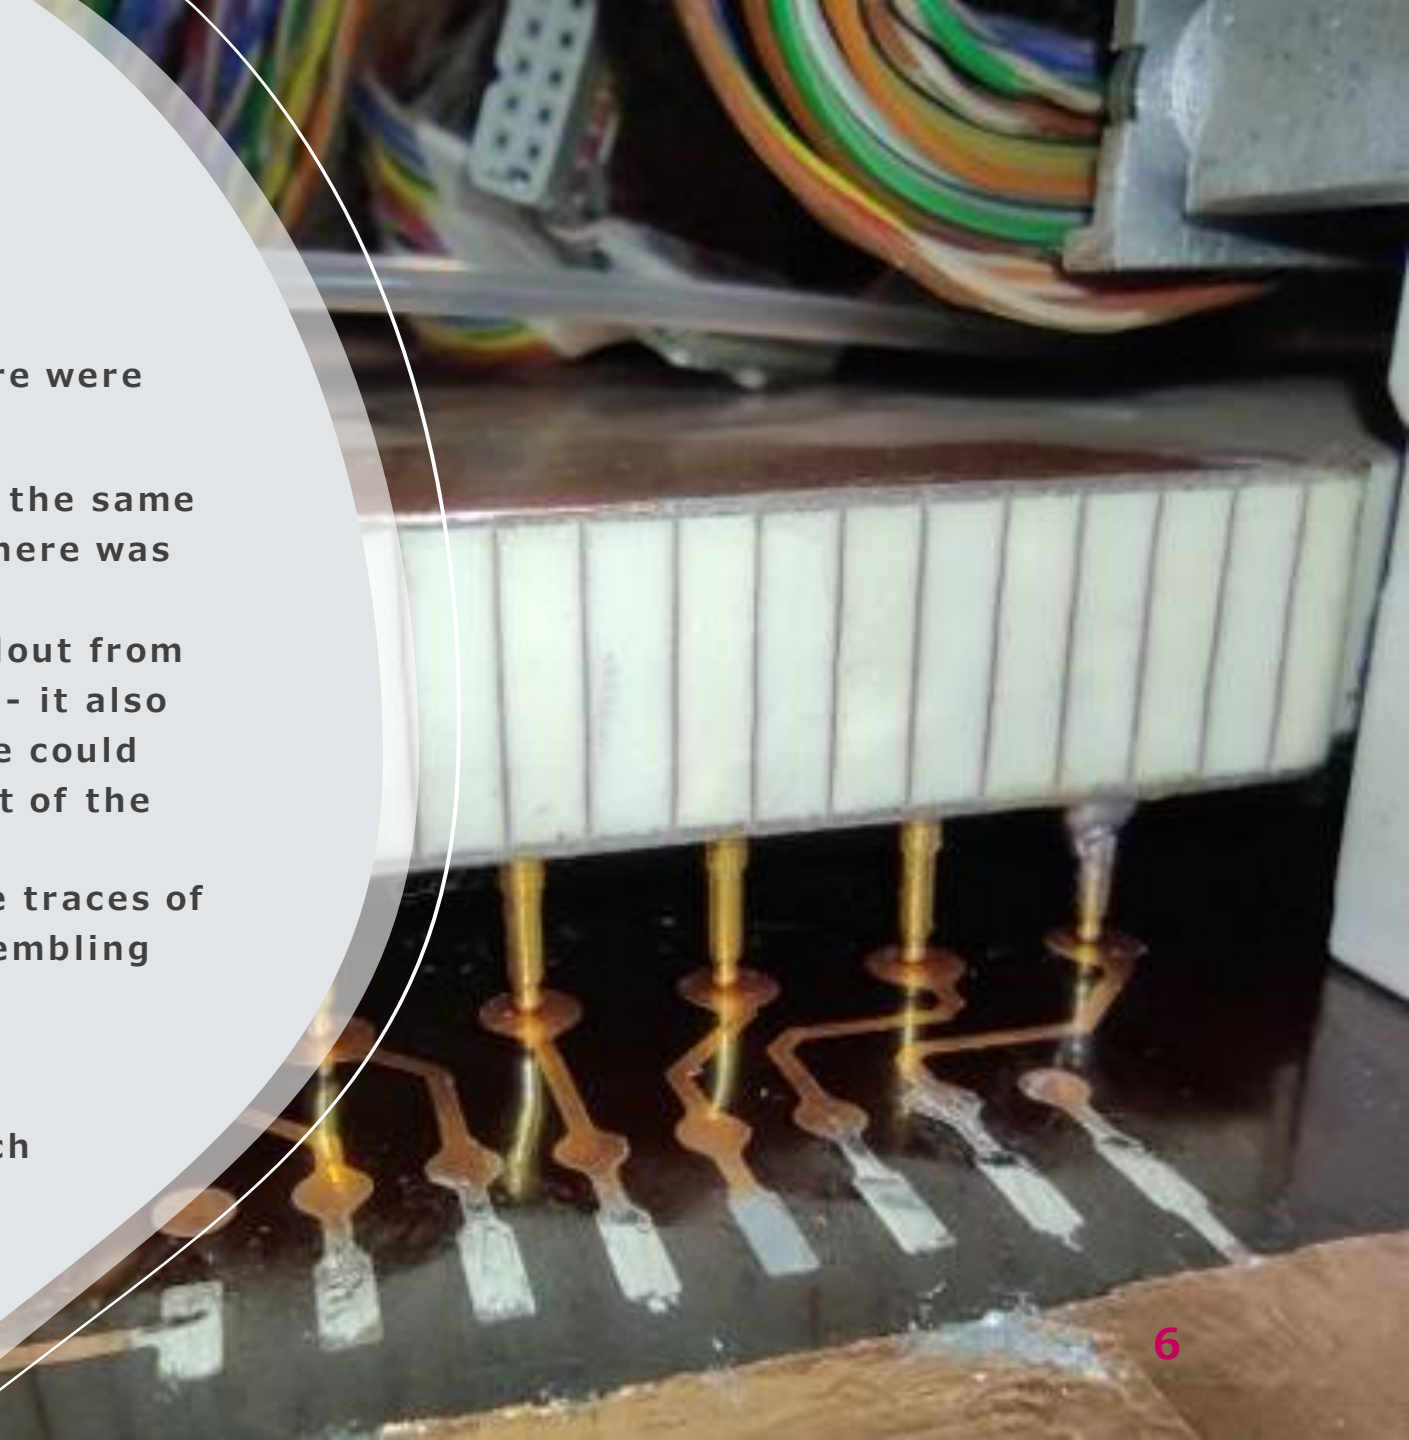
M7

The detector malfunctioned during the Run 8. There were trips, and it was impossible to set high voltage.

After the Run 8, we first replaced the divider with the same new one - it did not help. Then we assumed that there was a short circuit between the tracks on the readout board. Therefore, we isolated the readout from pins and connected HV divider directly to the pins - it also did not help. We discovered that during the trip we could hear clicking sounds somewhere in the central part of the detector. It is widely believed that the problem is somewhere in the internal part of the high-voltage traces of the detector, which can only be checked by disassembling the detector.

We decided to apply an independent voltage to each electrode.

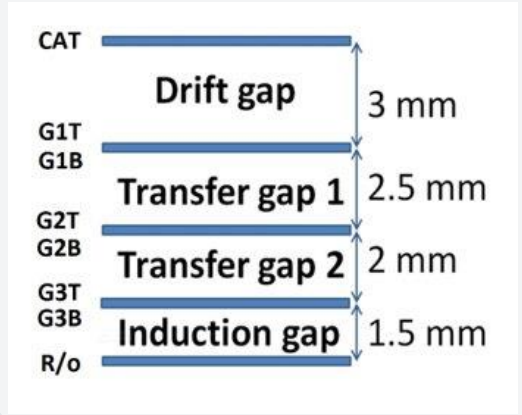
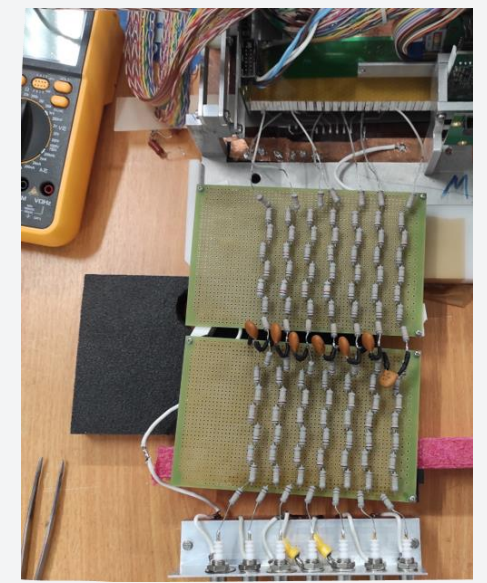
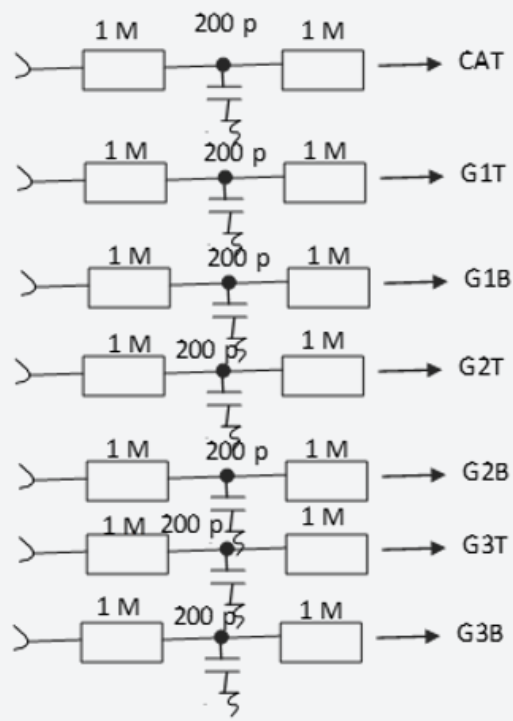
Separate high voltage supply to each electrode

Using this scheme, we can check how the GE M foils behave when the voltage changes.

Also, if we observe the current in the channel, we can say that the connection between the electrode inside the detector and the pin is not broken.

Due to this connection, the voltage on each electrode can be adjusted.

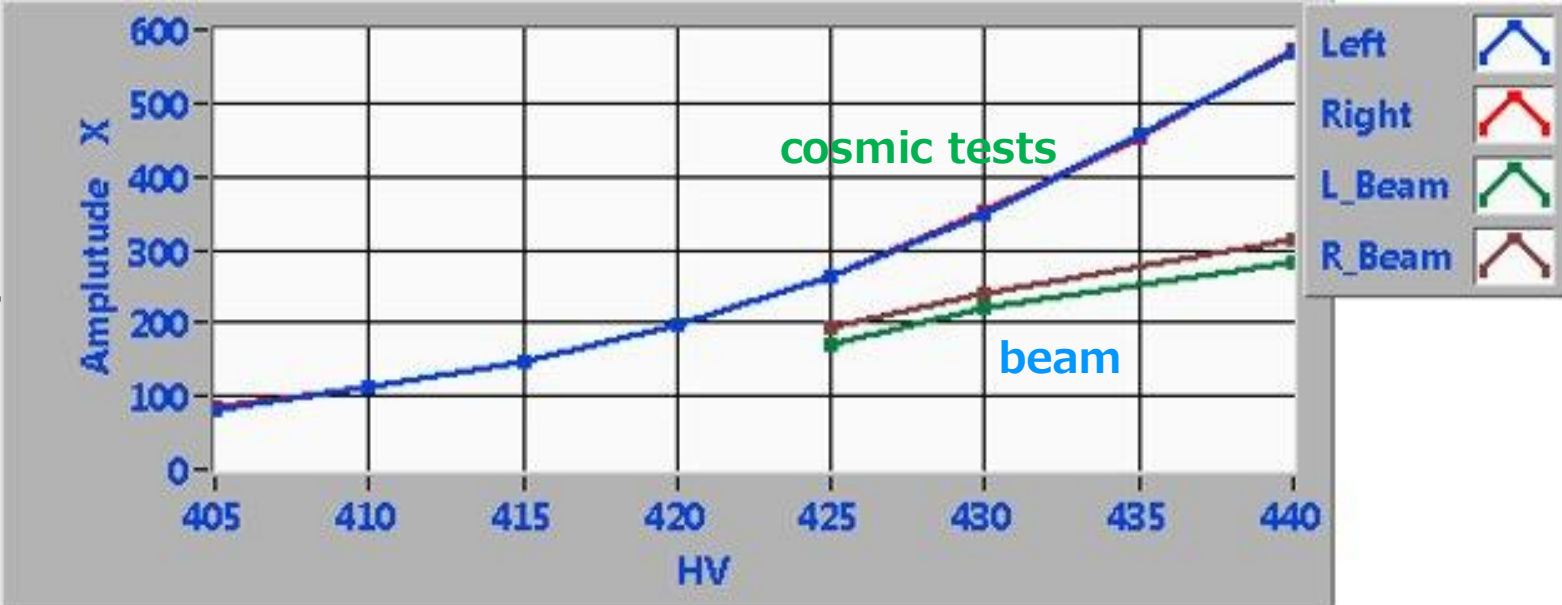
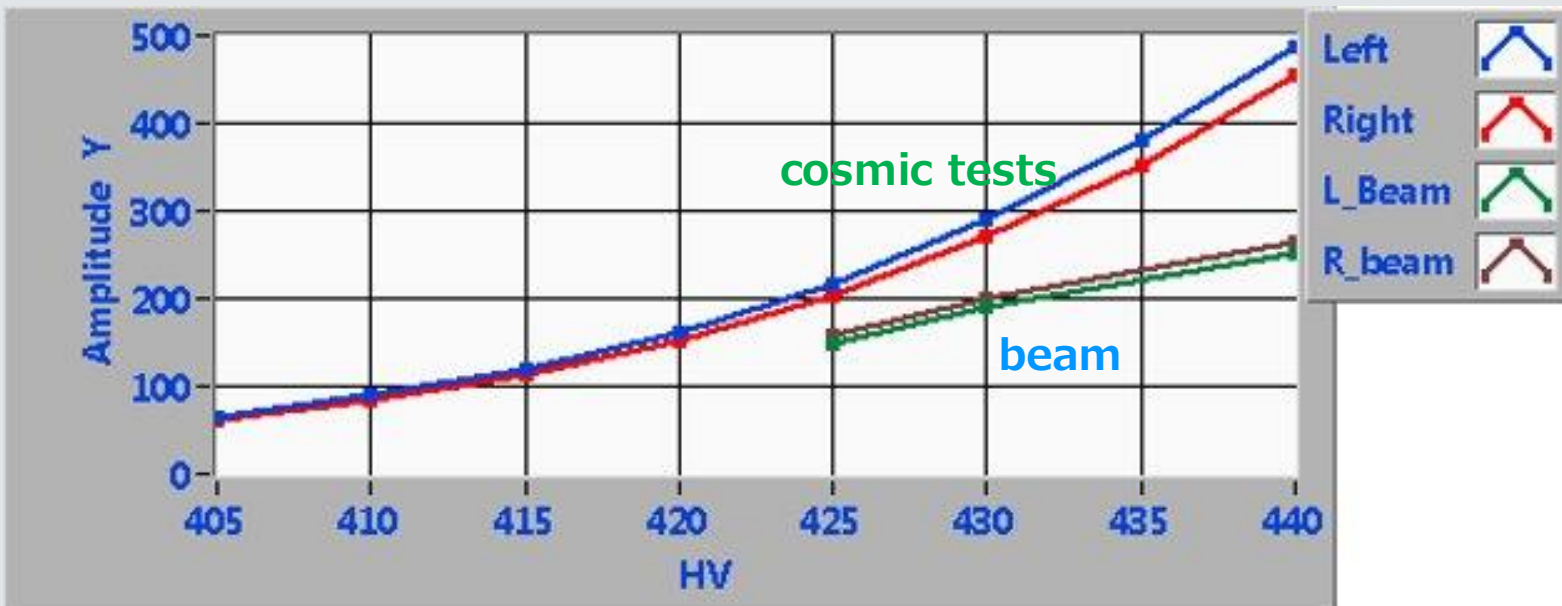
M10: amplitudes depending on the divider current

Distribution of X and Y amplitudes in the left and right sides of M10 for cosmic tests and for the beam depending on the divider current

The reason for this difference is still under investigation

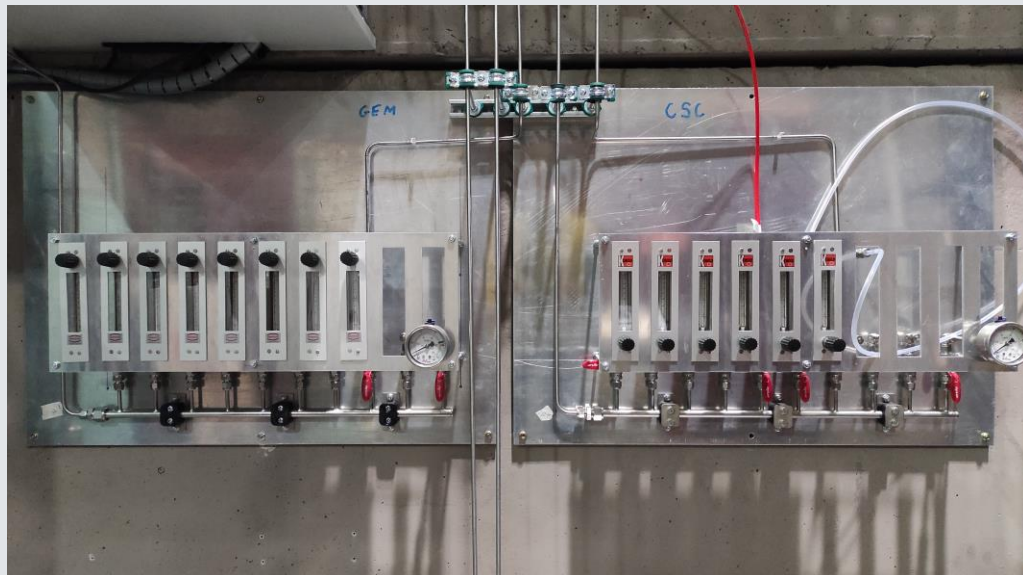
Gas collectors: GEM – left, CSC – right
