Status of the ToF system of the BM@N setup

M.M. Romyantsev on behalf of TOF group.

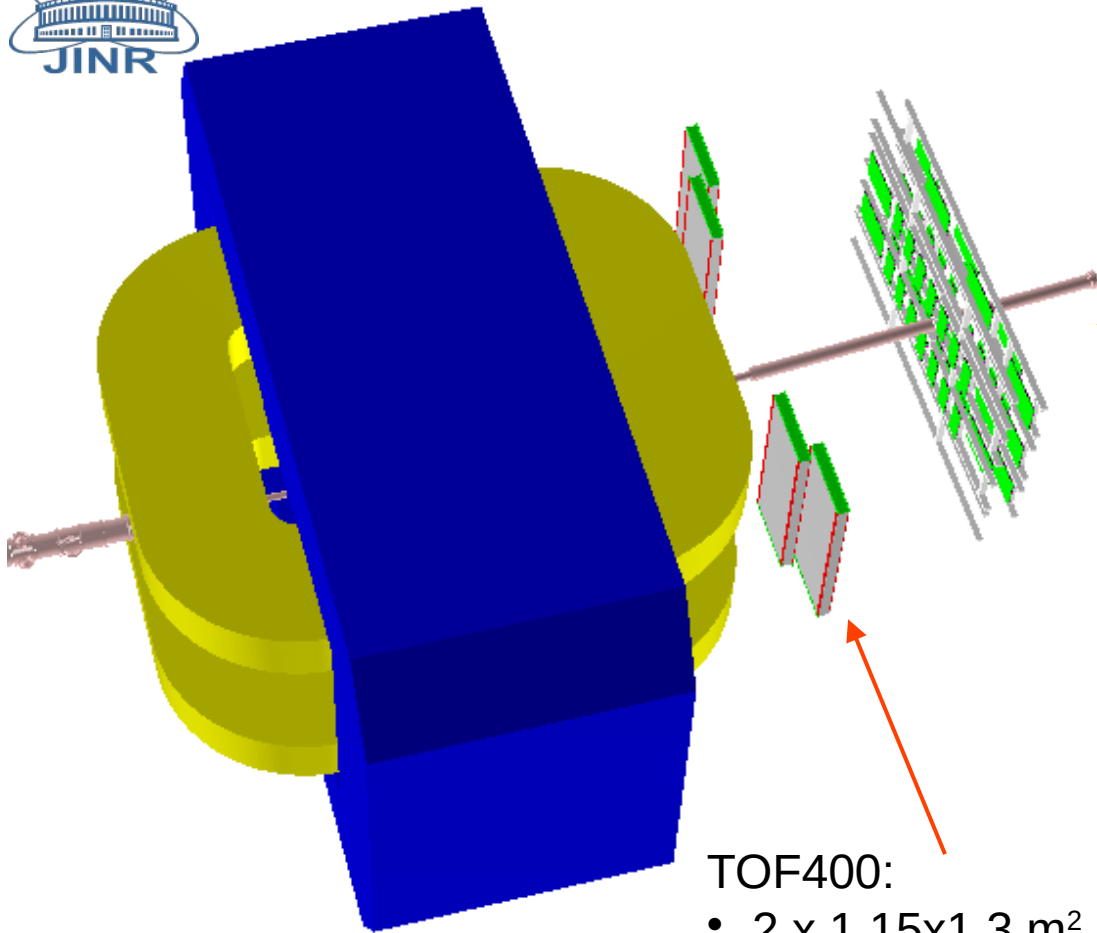
ToF System in recently run

TOF700:

- $3.2 \times 2.2 \text{ m}^2$
- 60 detectors of different size
- 3520 channels of FEE

TOF400:

- $2 \times 1.15 \times 1.3 \text{ m}^2$
- 20 detectors
- 1920 channels of FEE

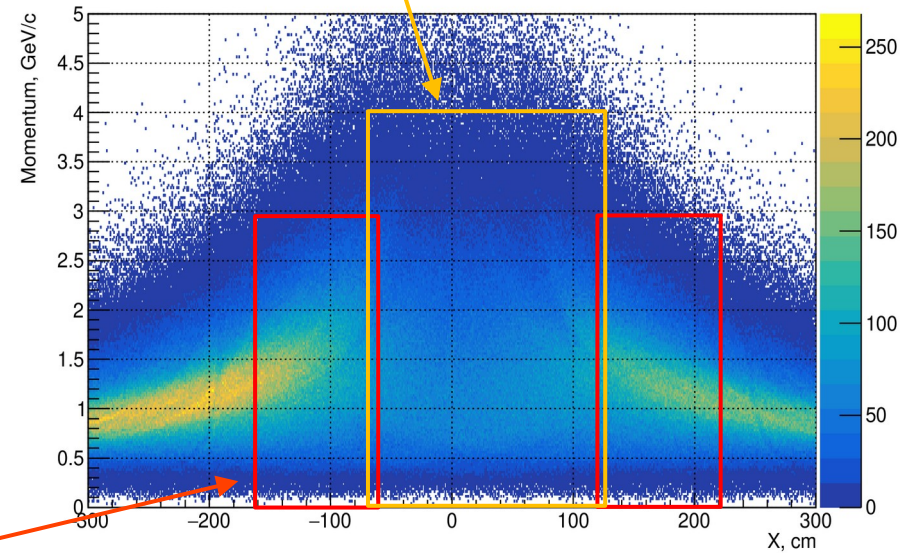
- All detectors worked normally.
- There are cases of HV breakdown (episodic). Some detectors in some runs did not work.
- One of the four HV blocks was repaired during the run.
- Future maintenance will be performed by the TOF400 group.

- Length cable correction
- Slewing correction
- MC TOF correction
- TOF700 alignment by tracks
- TOF tuning by protons.

Done
 Done
 Done
 No
 No

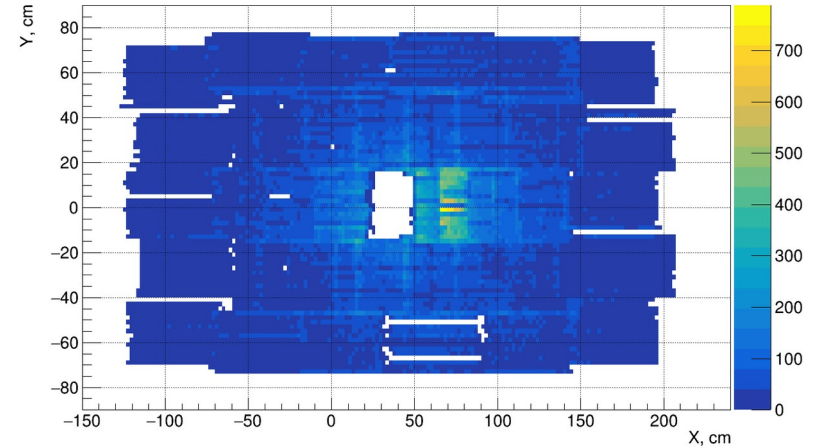
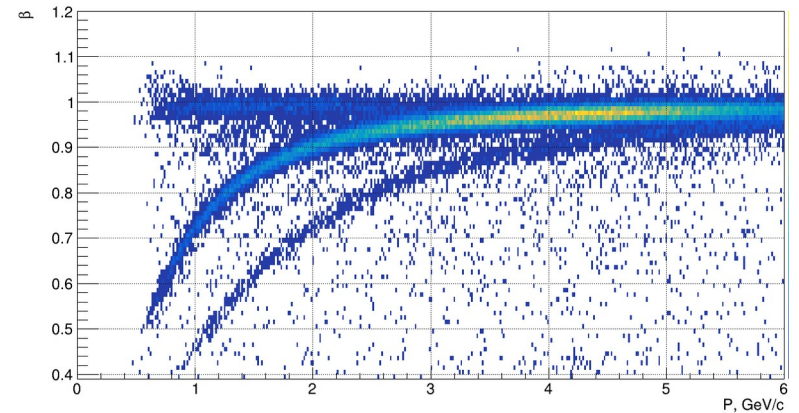
BmnTof700Hit.fY:BmnTof700Hit.fX

- All detectors worked normally.
- There are cases of HV breakdown (episodic). Some detectors in some runs did not work.
- TOF400 acceptance will be increased.

- Length cable correction
- Slewing correction
- MC TOF correction
- TOF400 alignment by tracks
- TOF tuning by protons.

Done
 Done
 Done
 In progress
 No

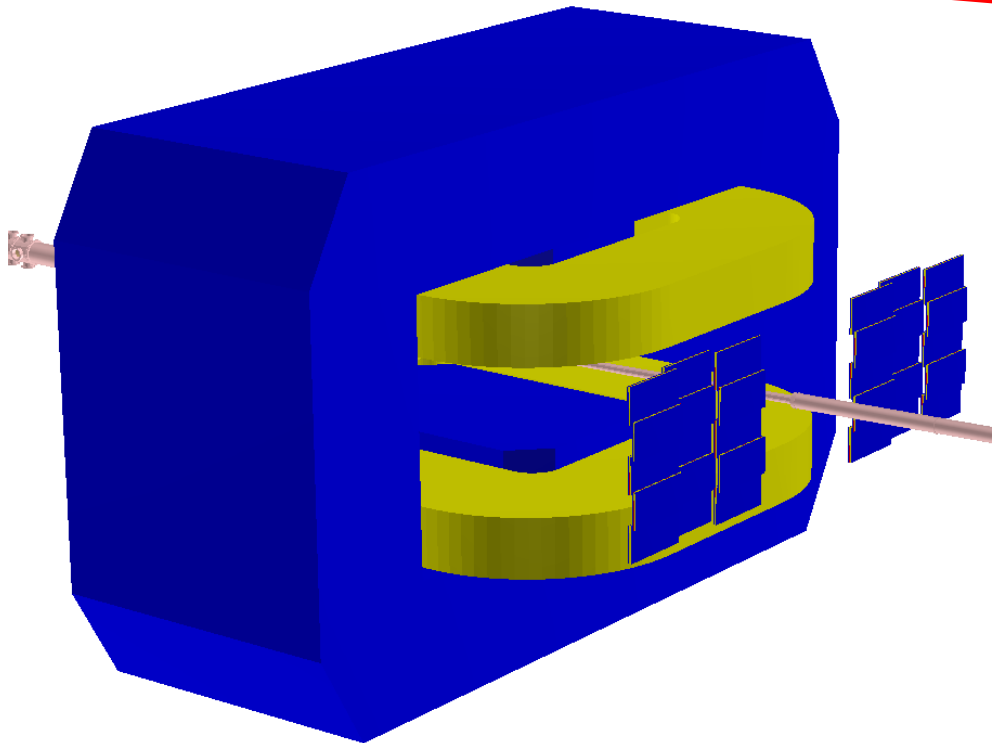
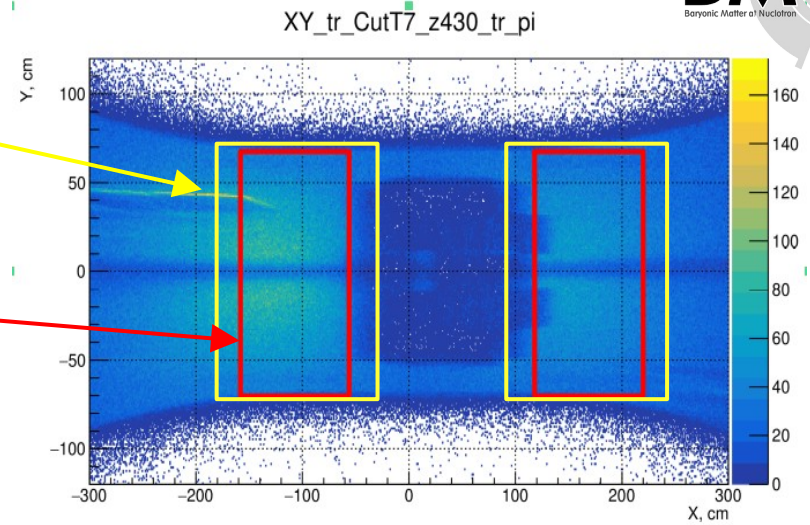
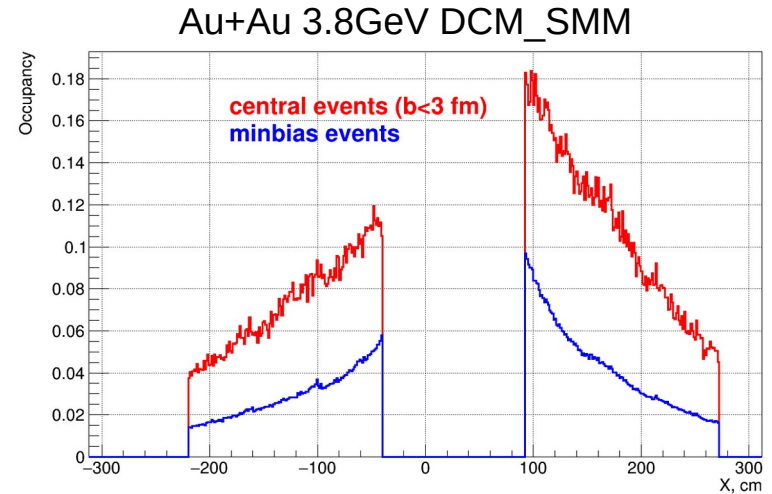
old configuration:

- 2 x 1.15x1.3 m²
- 20 detectors
- 1920 channels of FEE

new configuration:

- 2 x 1.7x1.3 m²
- 30 detectors
- 2880 channels of FEE

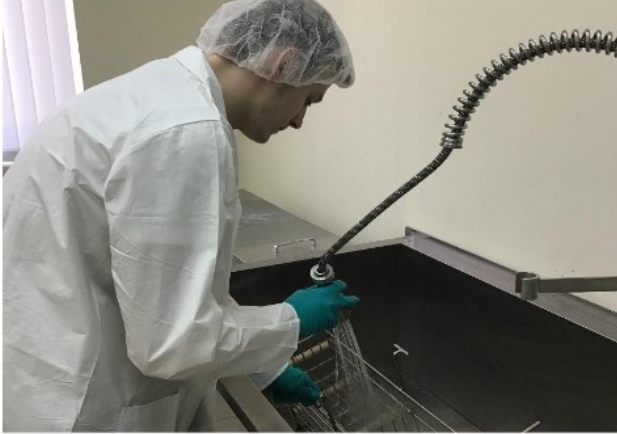
Glass cleaning with ultrasonic wave & deionized water

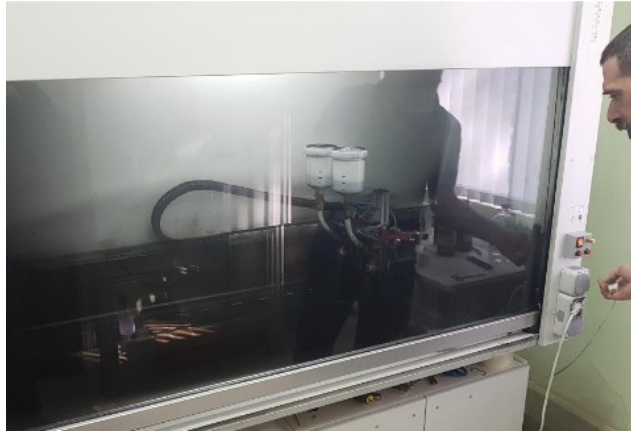
Automatic painting the conductive layer on glass

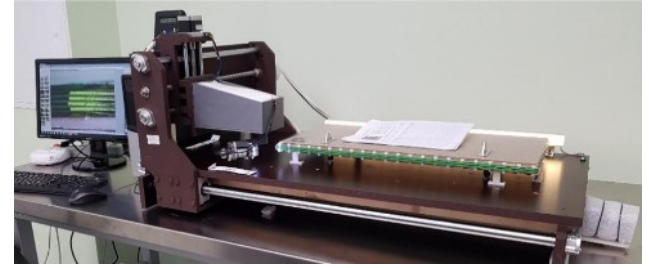
Optical inspection using a microscope

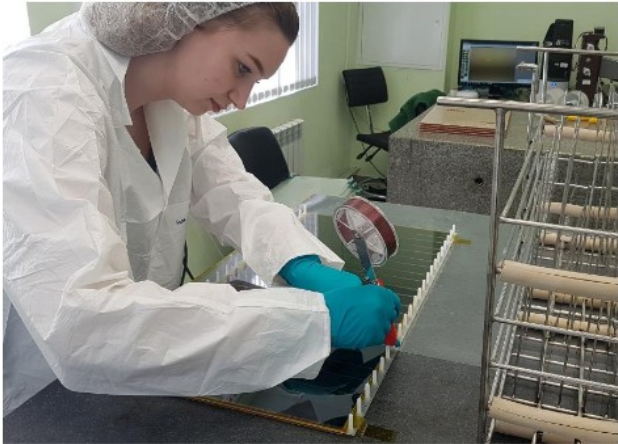
MRPC assembling

- Optic control (gap uniformity, cracks in glass)
- Primary HV testing (without gas) - up to 6 kV
- Readout pins and cables break, short-circuit and reversed polarity control
- Transmission line impedance (reflection) control
- Full HV testing (after fast pumping and filling with working gas mixture) – up to 12 kV

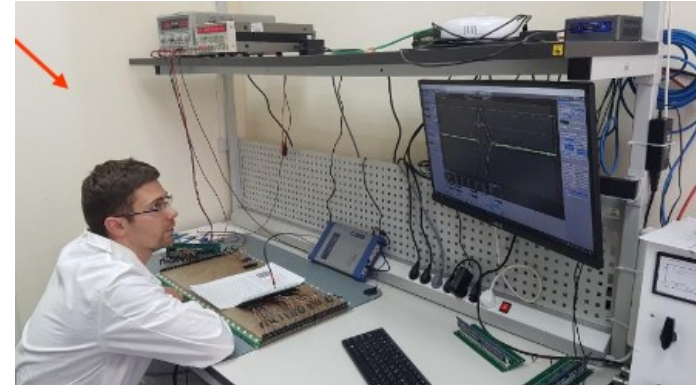
Transmission line impedance control

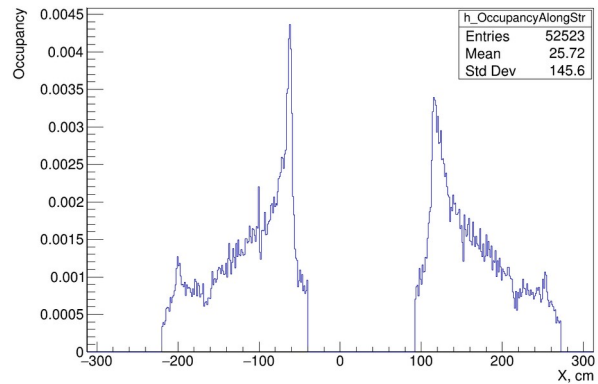
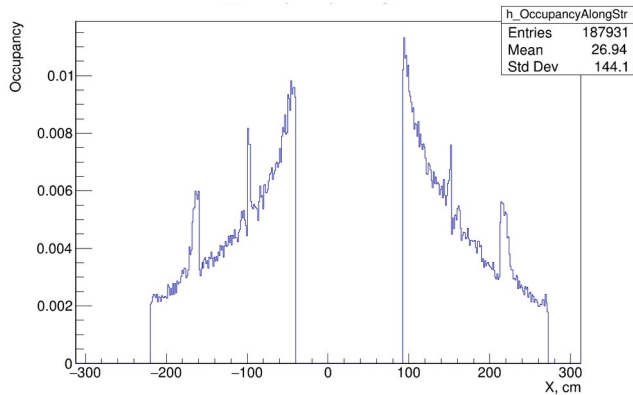
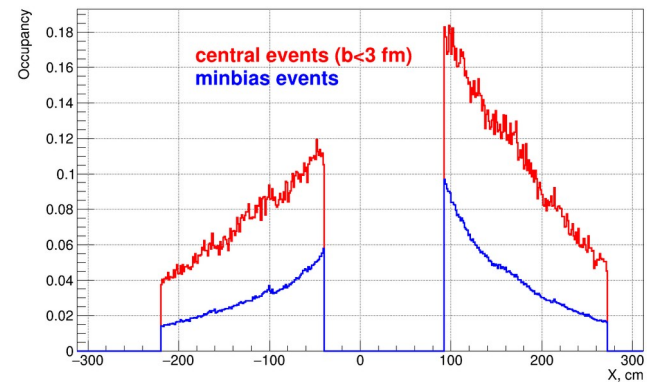
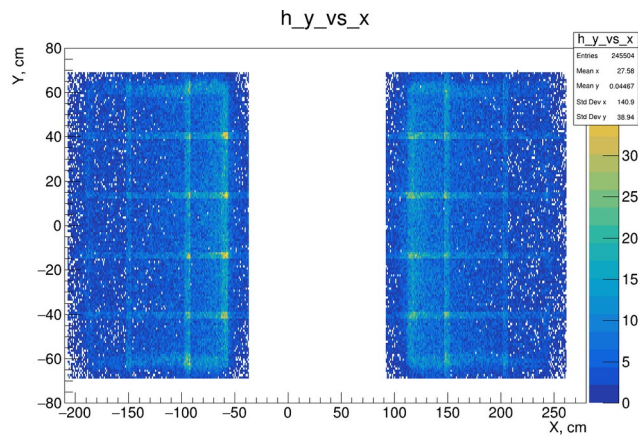
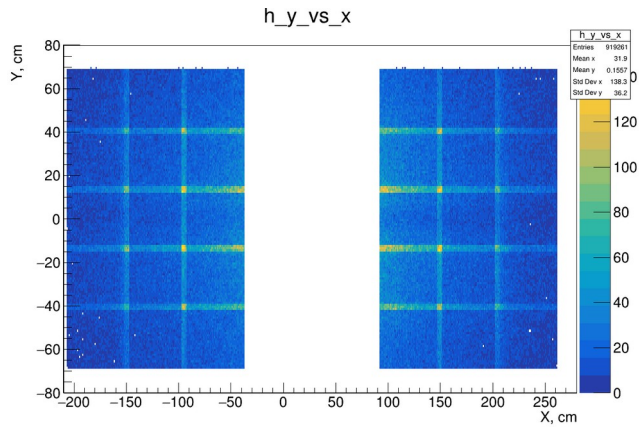
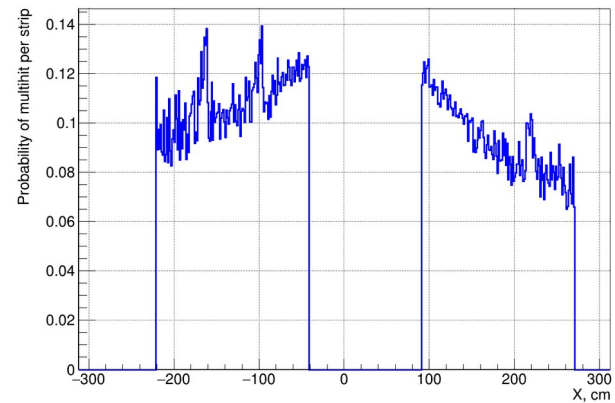
ToF400 extension MC simulation

Au+Au 3.8GeV DCM_SMM

Electrons coming from CSC before TOF

Electrons coming from TOF itself

All particles
