Status of the GEM and CSC systems

Elena Kulish on behalf of the
CSC and GEM groups

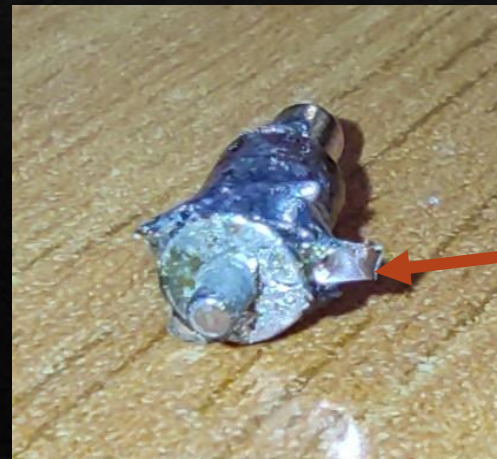
Destruction of the line and pad during resoldering

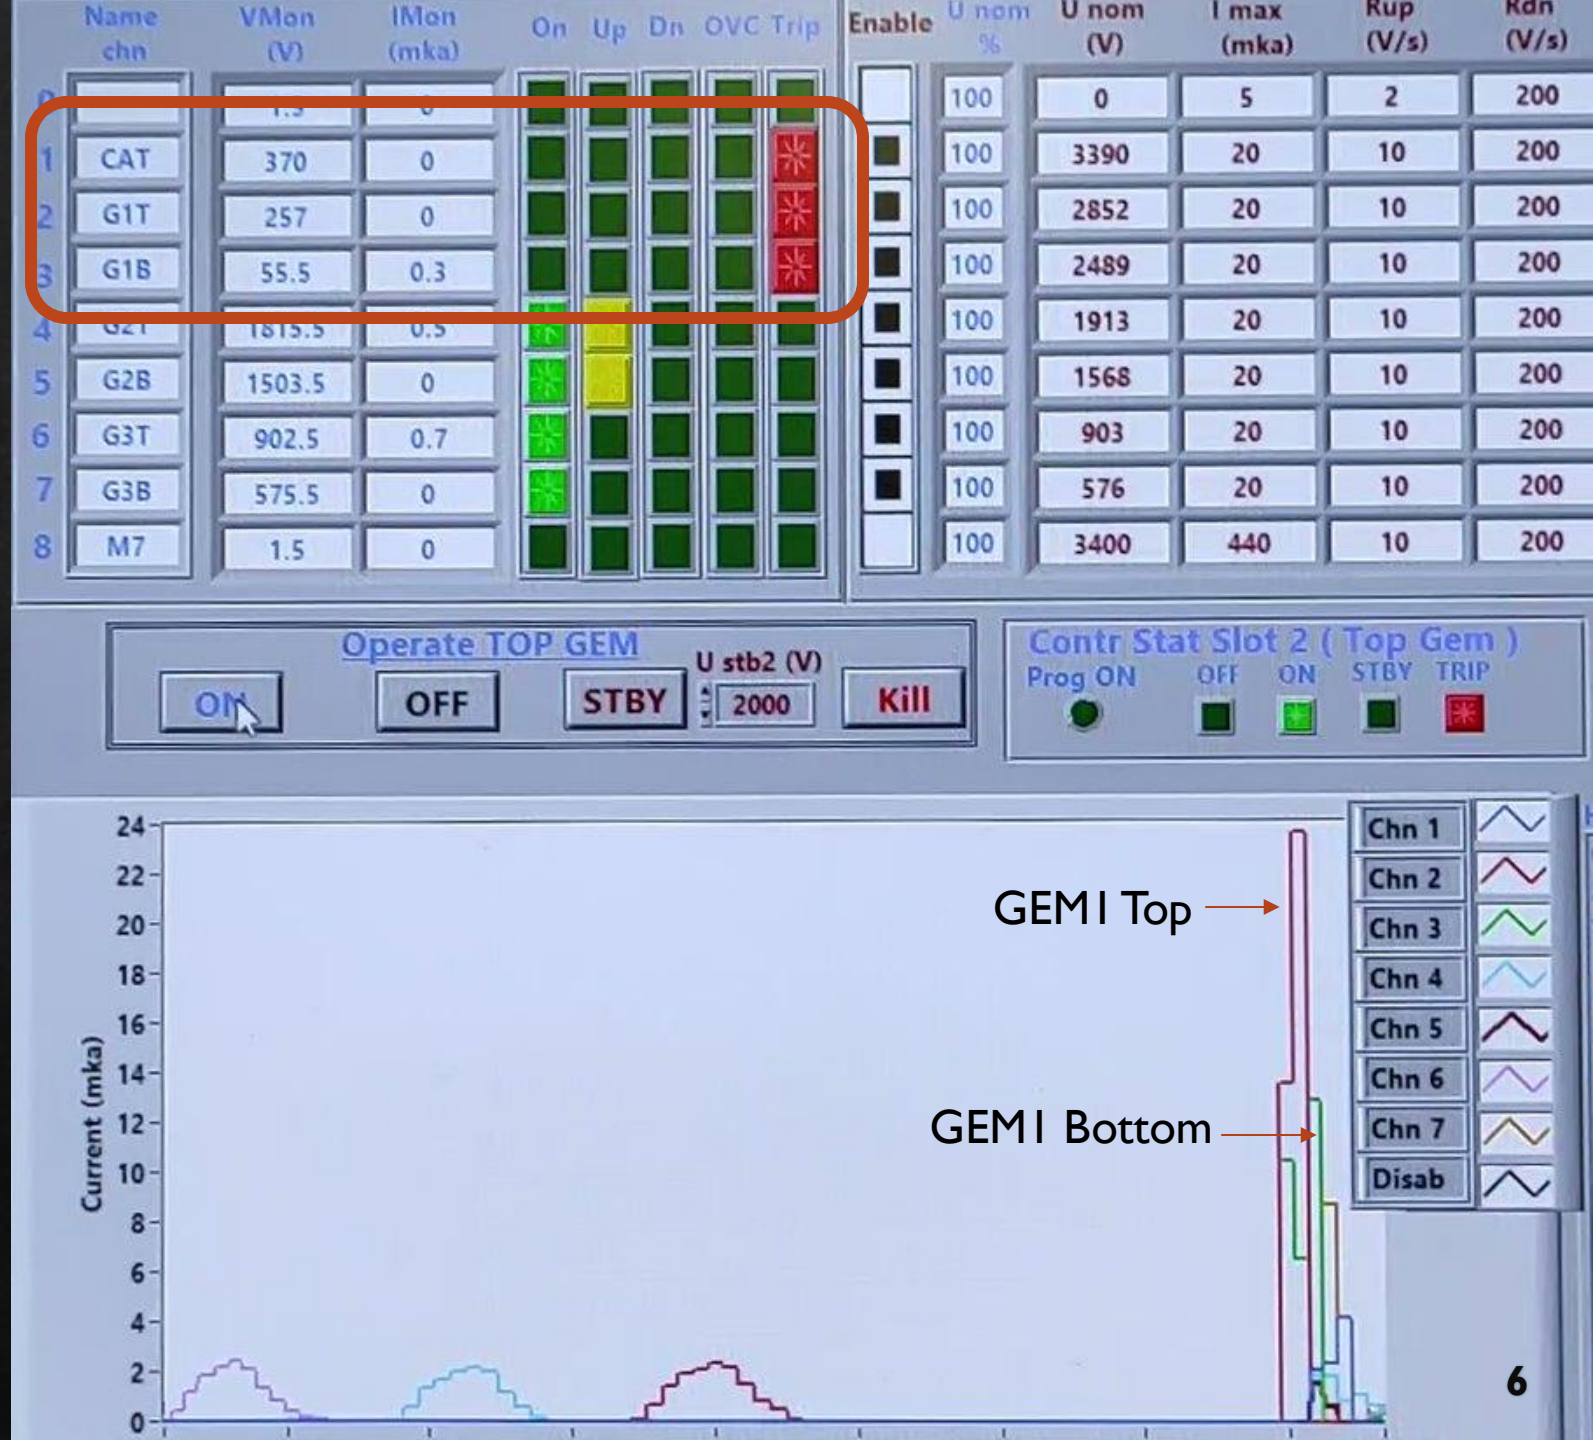
During testing with cosmic rays, the detector began to trip. It was decided to use a channel-by-channel high voltage supply to the detector electrodes. This means that we remove the divider and manually set the required voltage for each electrode. Using this scheme, we observed that the discharge occurs on the top foil and then on the cathode. We assumed that there was a dust in the detector.

To get rid of this, it is necessary to fill the detector with Nitrogen and try to burn the dust with an insulation tester. In case of M12, this procedure did not help.

We found a short in the top foil that could not be repaired while the detector was closed.

Therefore, it was decided to open this detector.

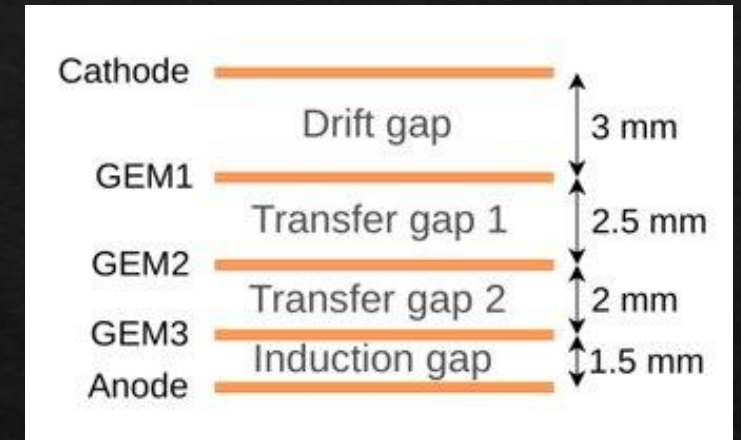
Schematic cross section of the GEM detector

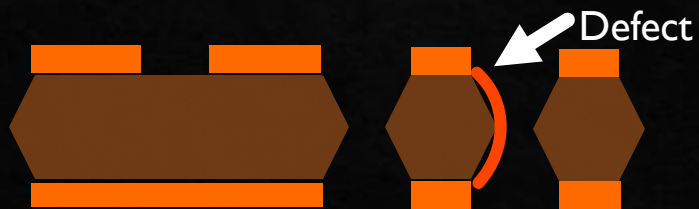
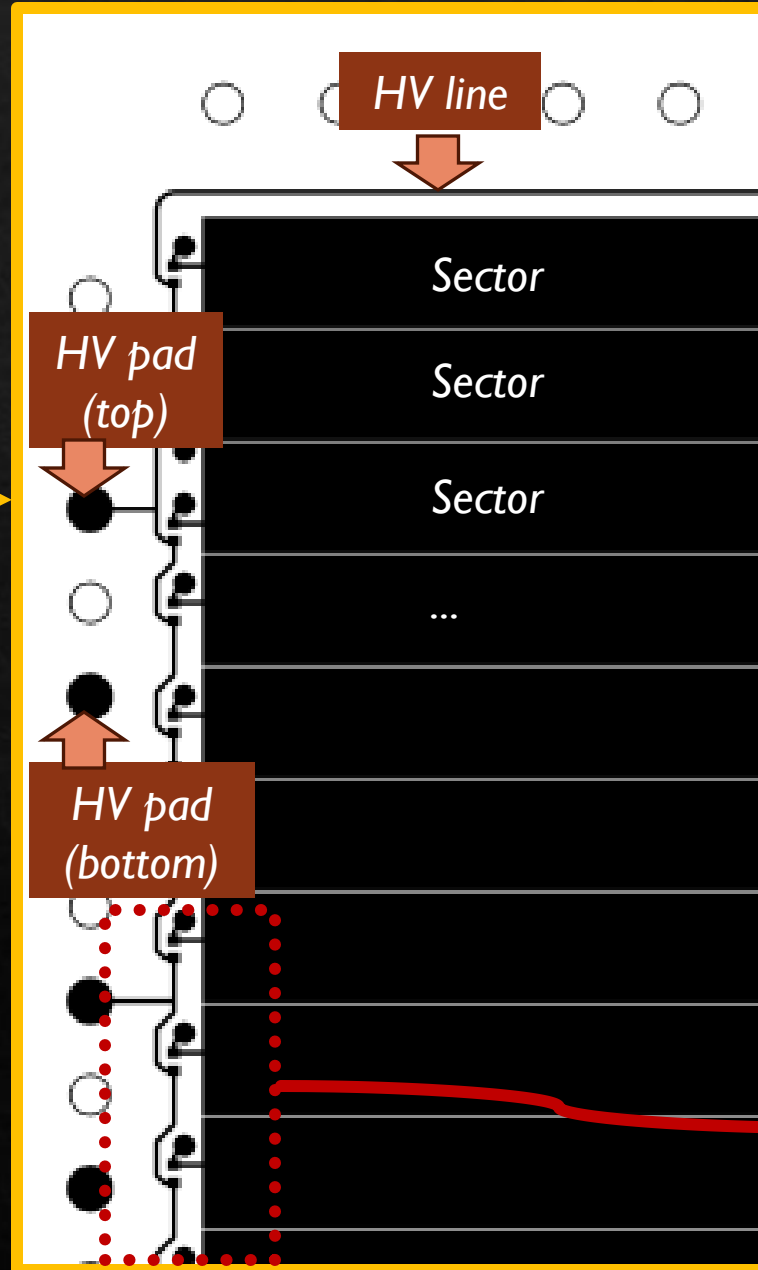
Opening of the GEM detector (M12)

To prevent dust from entering the detector when removing the cathode plane, a nitrogen gas line was connected to the detector.

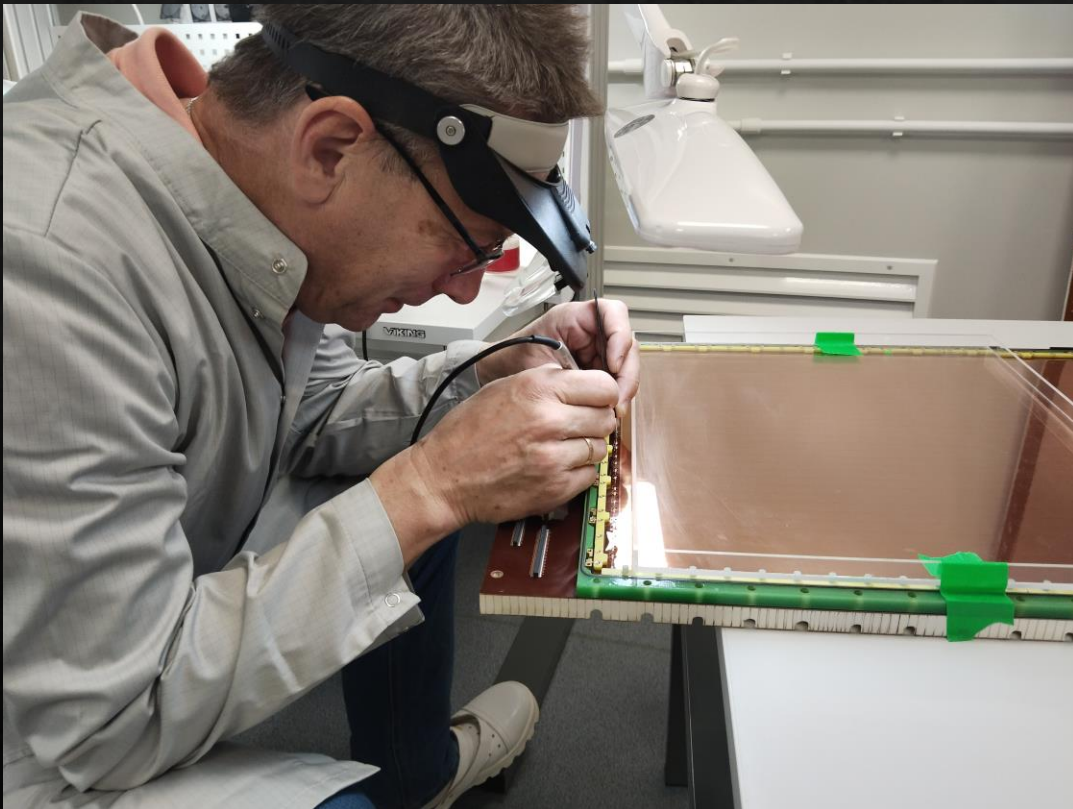
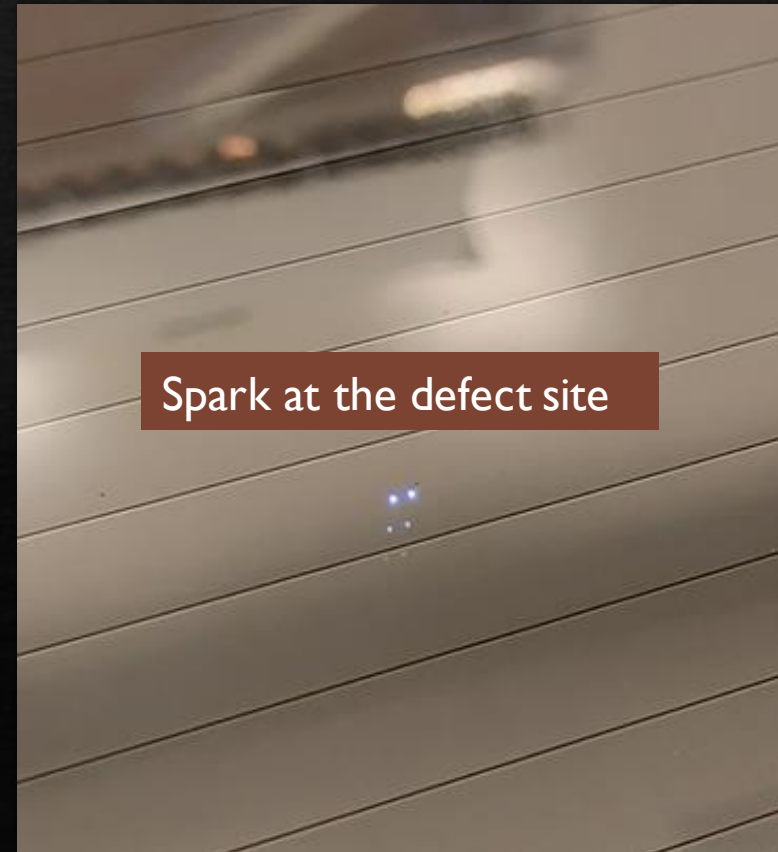
Burning out of the defects without resistors

Therefore, it was decided to unsolder the resistors and try to burn through the defects by applying high voltage directly to the sector.

Normal use of an insulation tester did not help. Semen Piyadin suggested using it as a capacitor. This means charging the device when the probes are not into contact with the sectors, and discharging through the sector. This method led to a successful result. Short circuits were burned out.

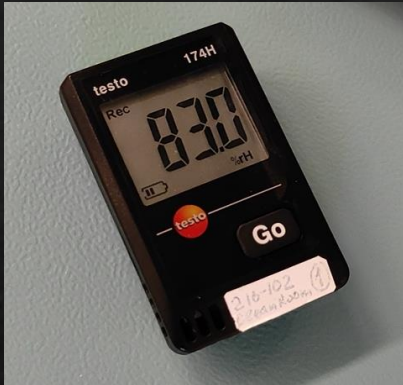
Humidity and the GEM

Changes in weather have increased the humidity in the cleanroom. We saw a decrease in the resistance on the foil. Applying high voltage to the foil led to new short circuits. The foil became wavy.

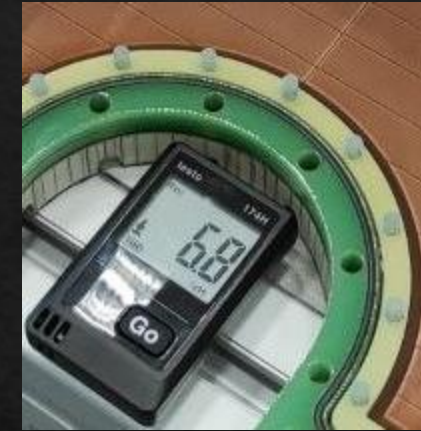
Waves on the foil

The detector was moved to another clean room with an air humidity of 7%. During the day, the detector dried out and some short circuits disappeared. The remaining short circuits were burned out.

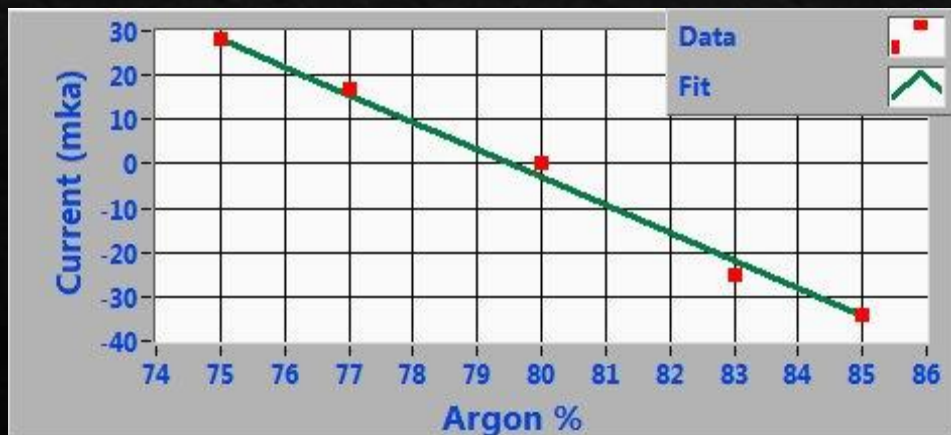
Dependence of the divider current on the percentage of Ar in the mixture

$\pm 1\% \text{ Ar} \longrightarrow \pm 6,2 \mu\text{A} (\pm 50\text{V})$

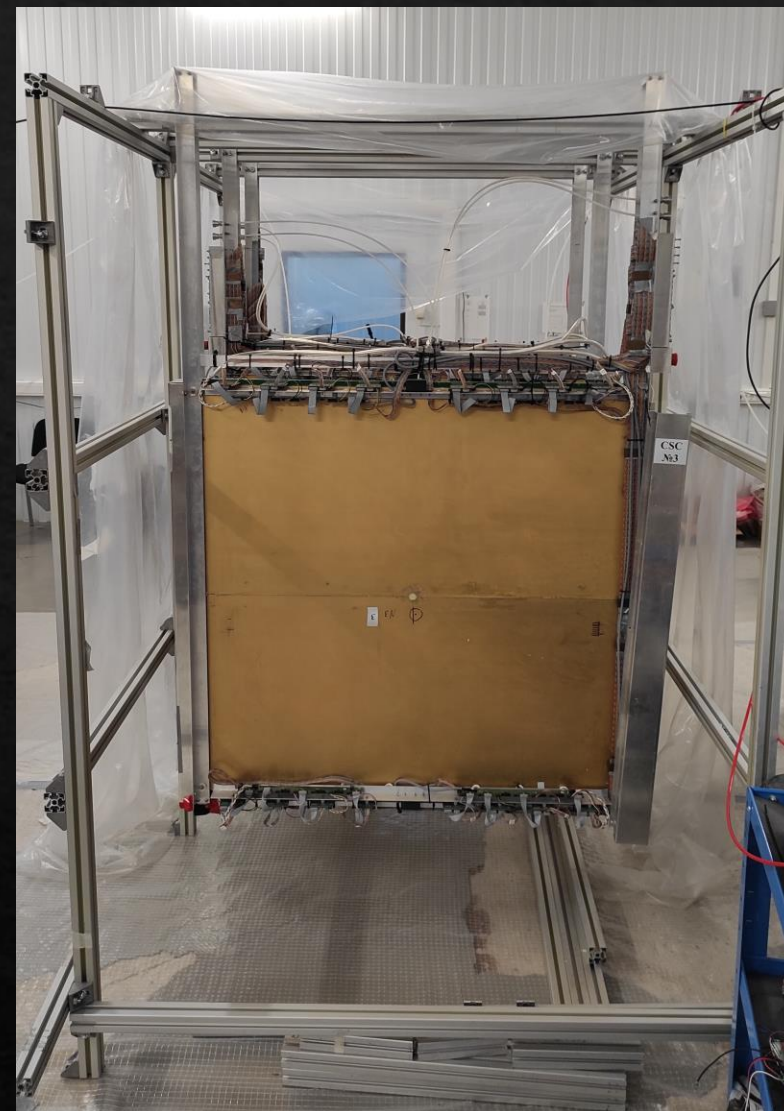
CSC status

2 Large CSC are installed.
Installation of 4 CSCs will be carried out after all GEM detectors
will be installed. Installation sequence is following:
2 CSC, 2 new ToF-400, 2 CSC
