# The modernization in the experimental hall

Piyadin S.M.

12.03.2024

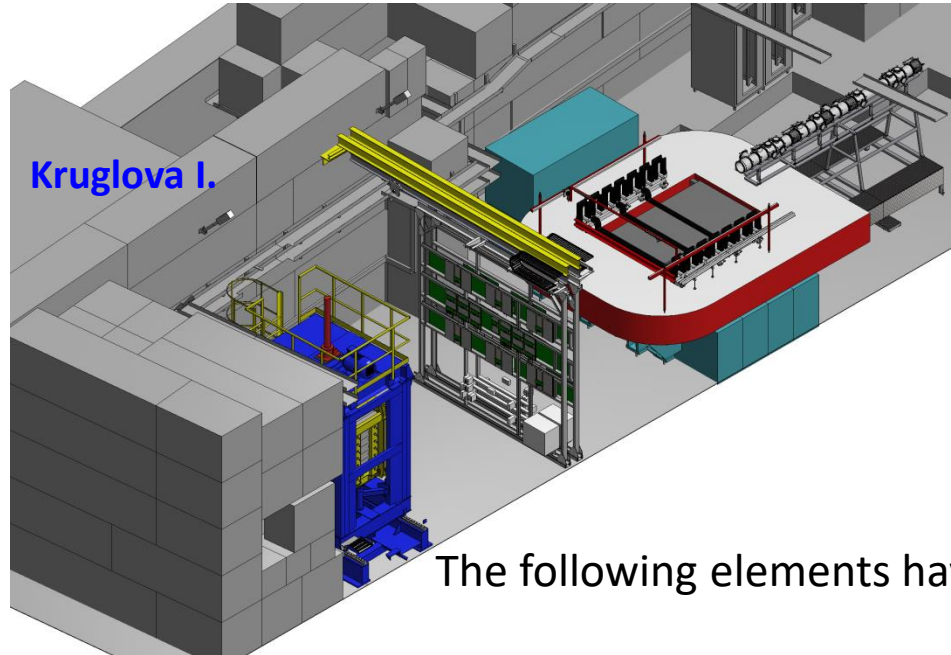
The following elements of the BM@N installation were removed after Run 8:

1. 4 detectors ToF400;
2. 4 detectors CSC 1x1m;
3. CSC 1,5x2m;
4. FD;
5. small Gem;
6. Aluminum beam pipe;
7. SiMD;
8. 8 planes forward Si;
9. 14 Gem;
10. Carbon beam pipe;
11. DCH1;
12. DCH2;
13. ScWall;
14. Target Station.

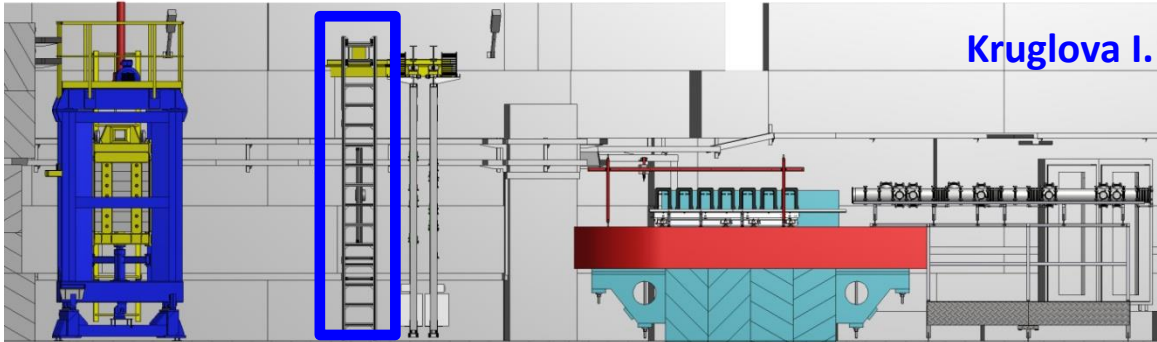
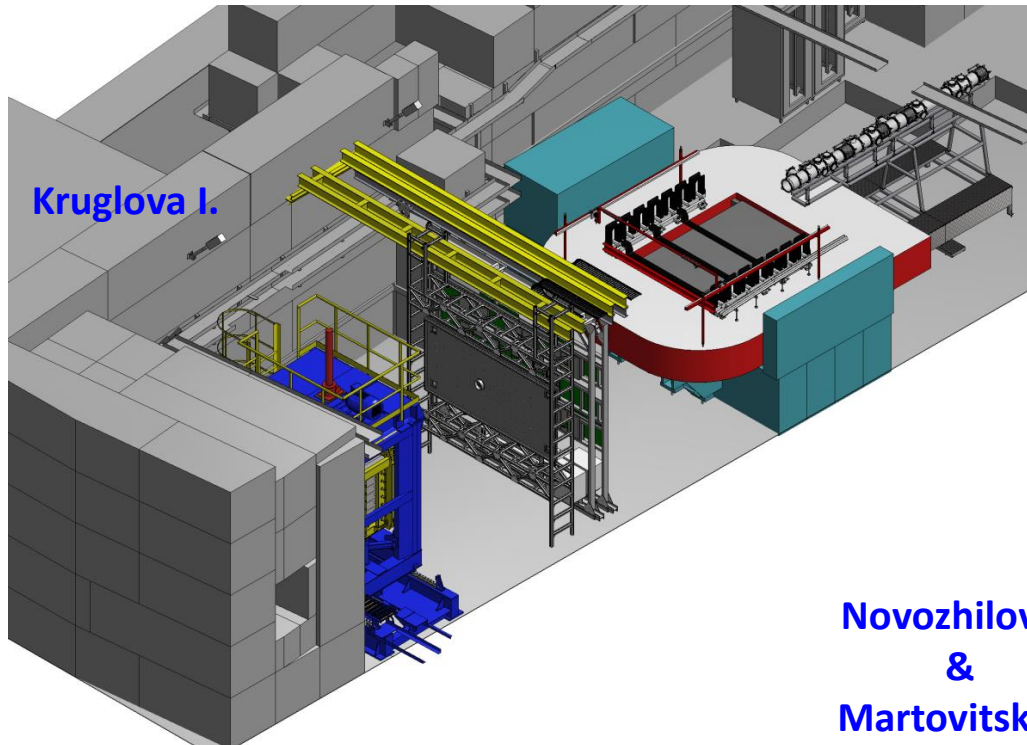
The following mechanical support elements have been prepared:

1. Mechanical support materials: **Yes**
2. Supporting structure for mechanical support : **Yes**
3. Brackets for fastening the supporting structure : **Yes**
4. Mechanical Support Project: **Yes**
5. The detector is ready for installation: **Yes**

ScWall is completely installed in the experimental hall now

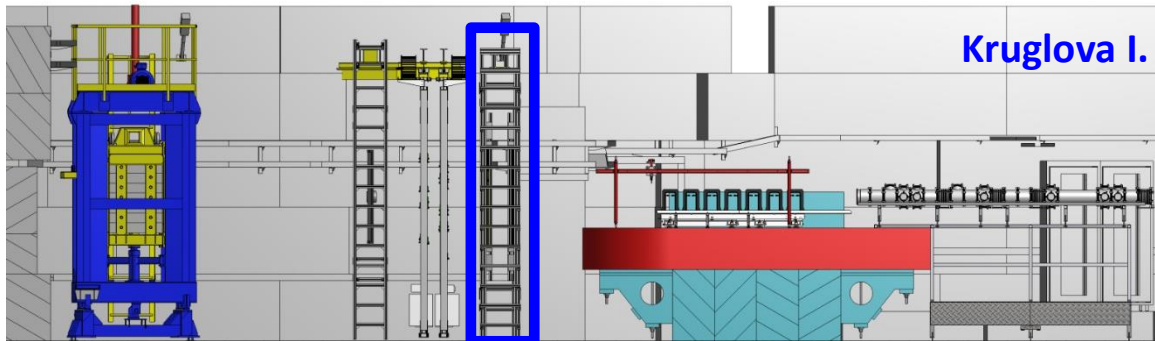
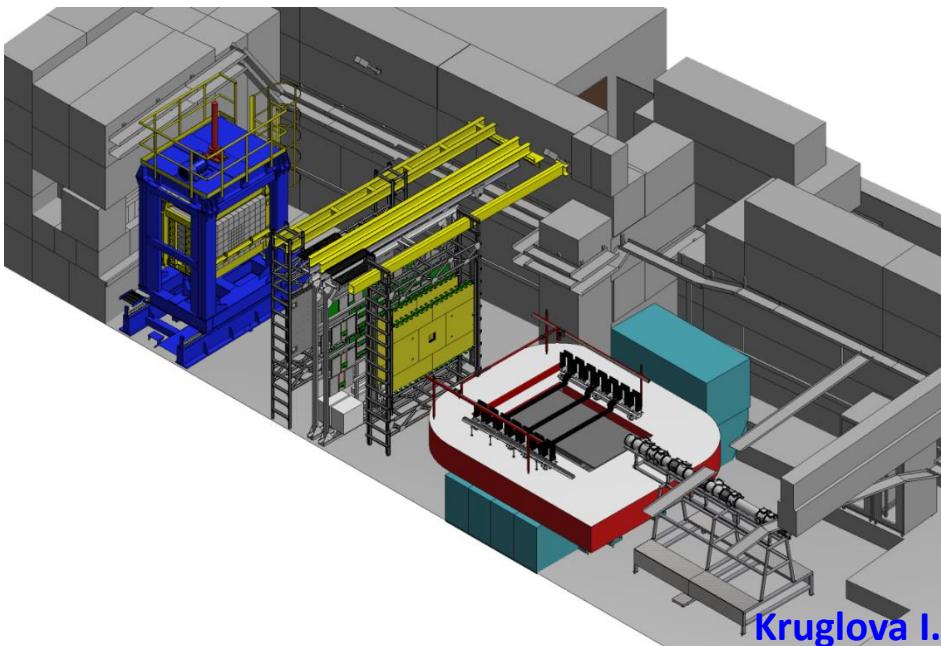
1. Mechanical support materials: **Yes**
2. Supporting structure for mechanical support : **Yes**
3. Brackets for fastening the supporting structure : **Yes**
4. Mechanical Support Project: **Yes**
5. The detector is ready for installation: **Yes**

2 CSC big are completely installed in the experimental hall now

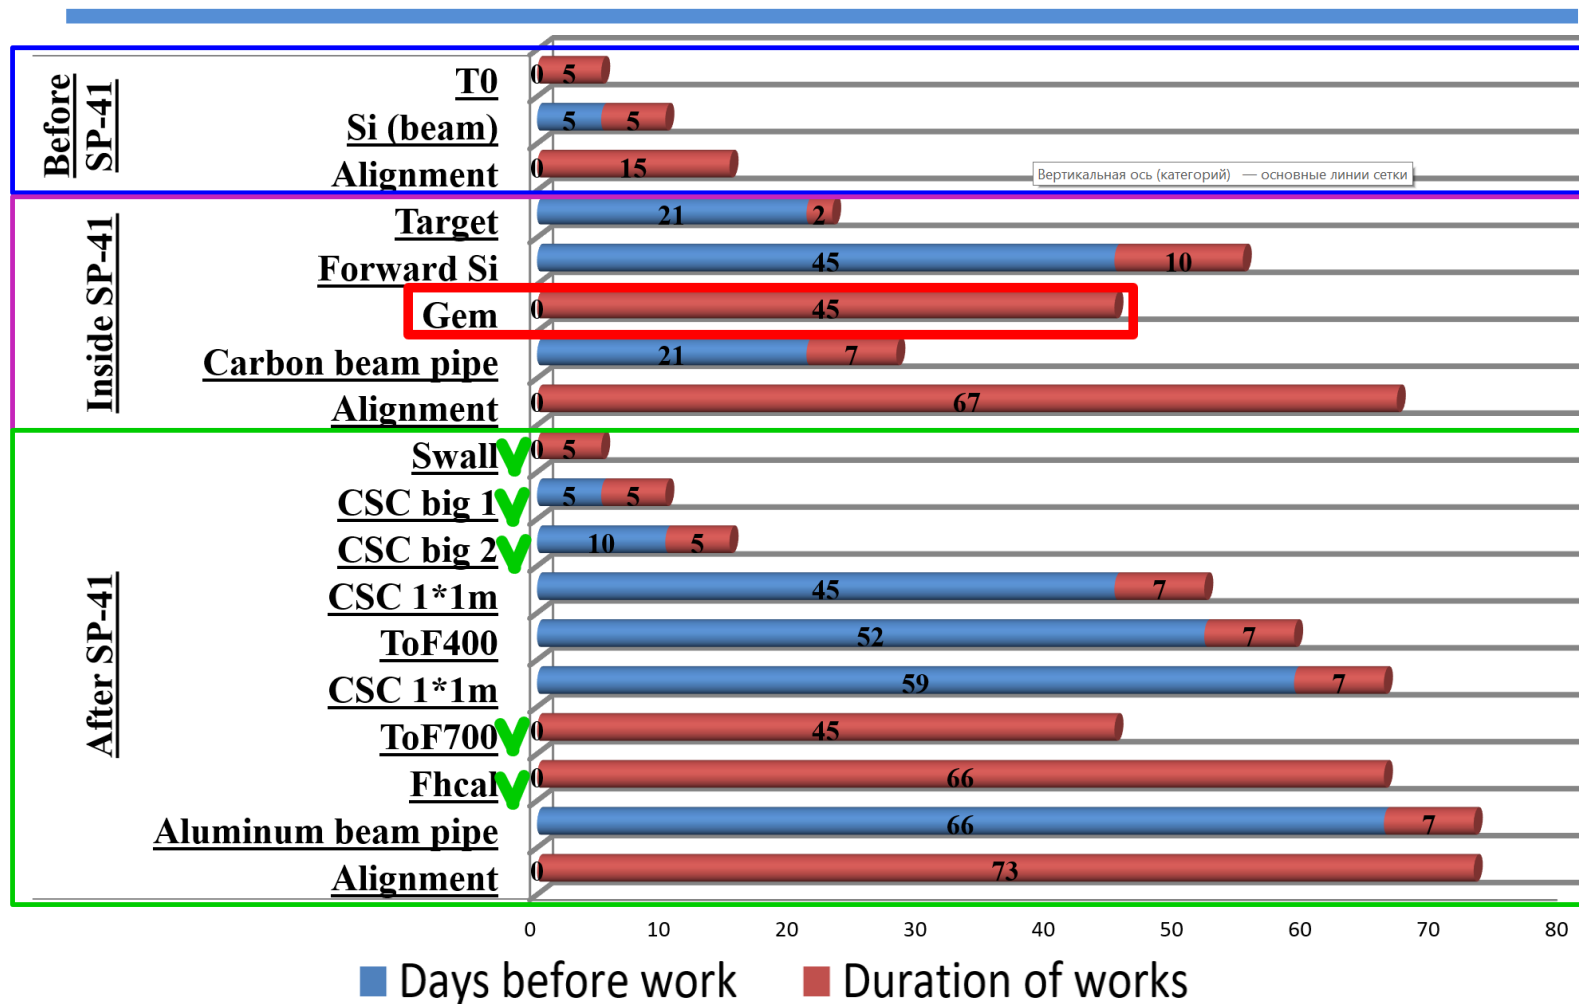
The table is divided into 3 zones.

In zone 3, work can be carried out in parallel.

But work on installing TOF 400 and GEM can only be carried out one after the other.

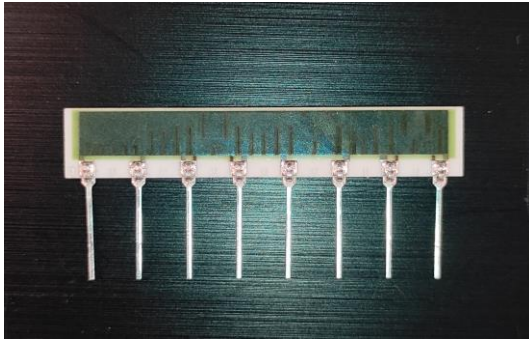
Divider old configuration

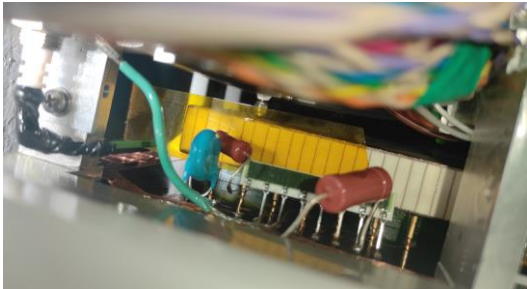
Location of the old divider on the Gem detector

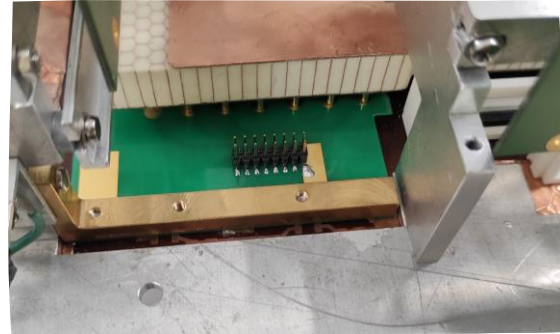
The board on the detector

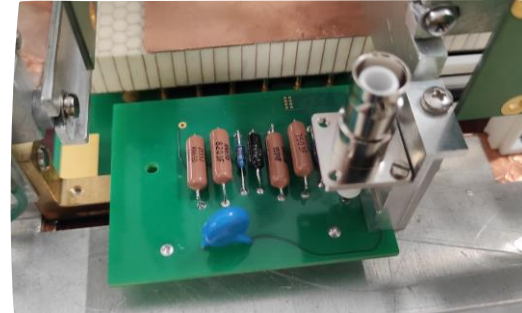
Divider new configuration

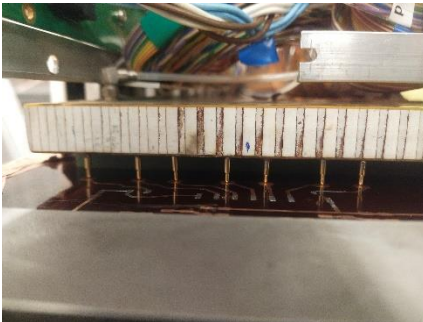
High voltage pin old configuration

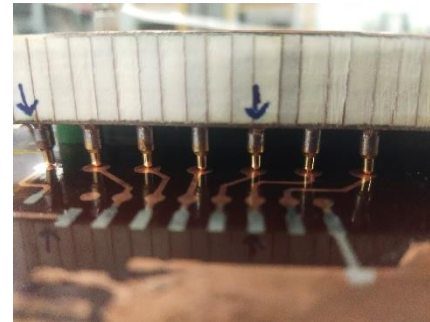
High voltage pin new configuration

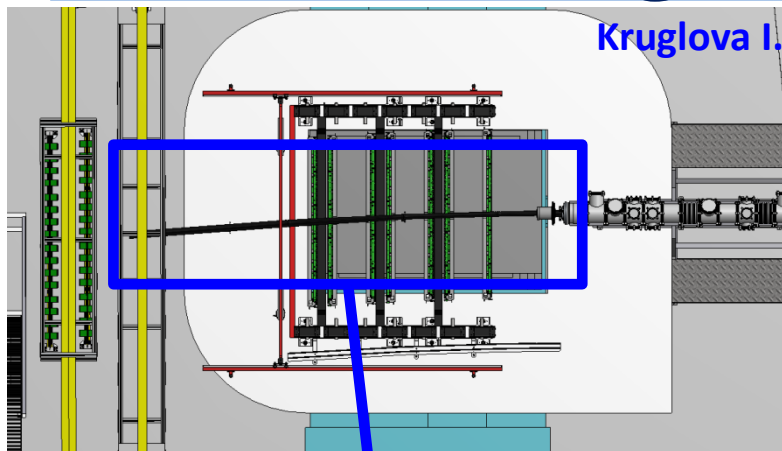
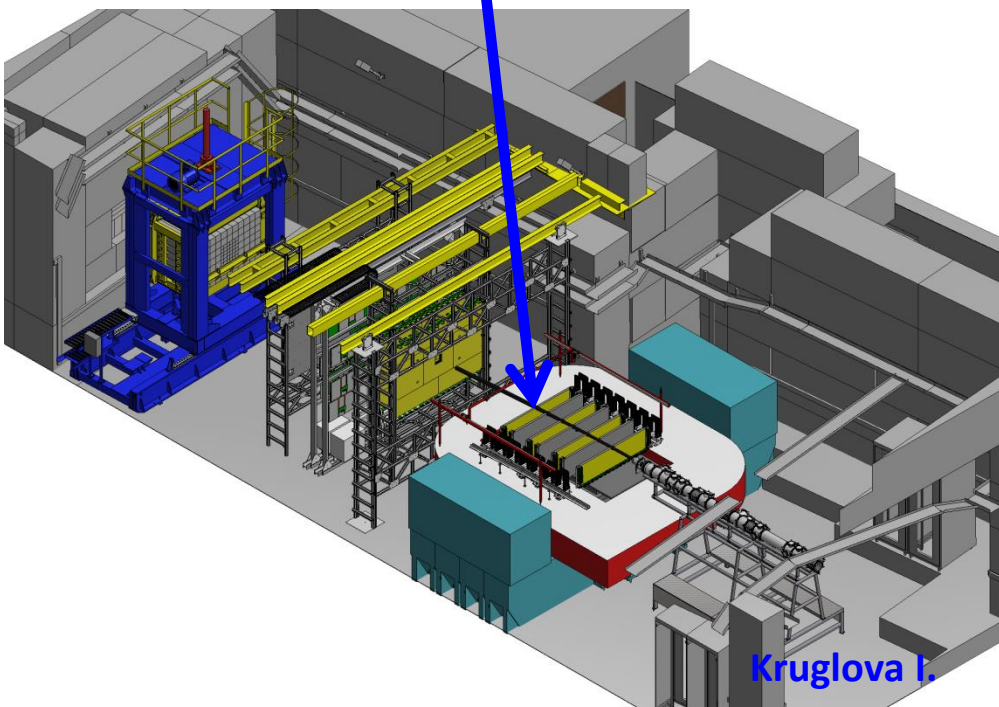
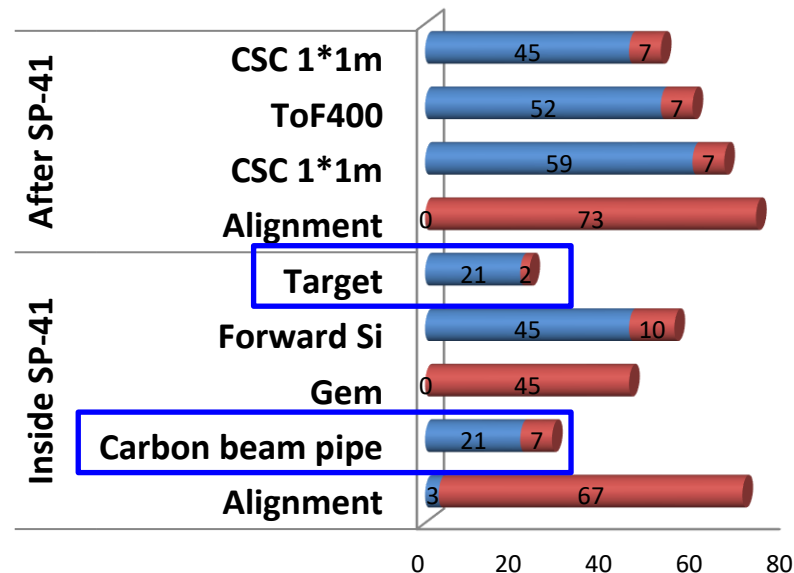
1. Carbon beam pipe is ready for installation: **Yes**
2. Target station is ready for installation : **Yes**

We will start installing the target station and carbon tube after installing the 7 bottom GEM detectors.

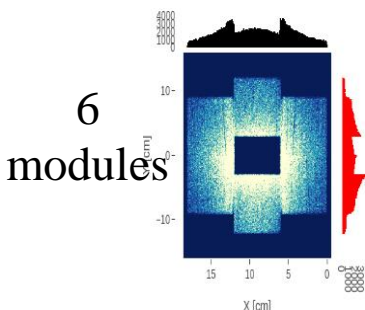
10 modules

**PI#1:**  
 $I_d = 8.9 \mu\text{A} / 8.2 \mu\text{A}$   
*(100% chips work, there were no problems)*

The correlation plots for Forward Si detectors obtained during Run 8.

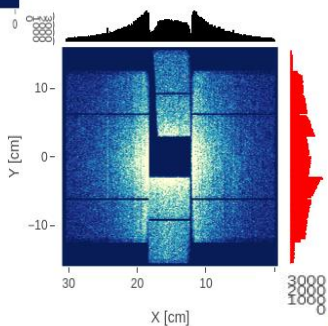
14 modules

**PI#2:**  
 $I_d = 27.6 \mu\text{A} / 28.5 \mu\text{A}$   
*(1% chips didn't work = 1 chip of 100 pcs., as of 09/26/23 everything is 100% working)*

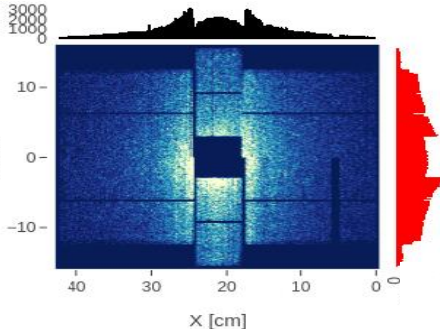
18 modules

**PI#3:**  
 $I_d = 40 \mu\text{A} / 48 \mu\text{A}$   
*(2 chips out of 140 do not work)*

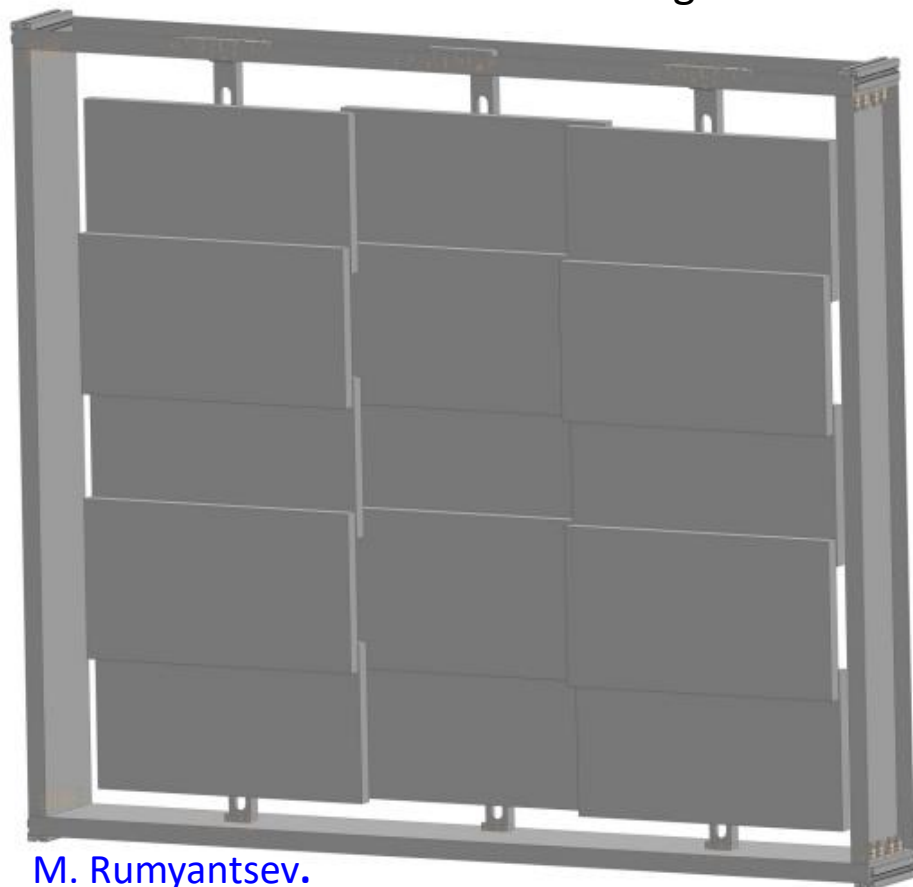
We decided to expand ToF400 acceptance.  
To do this we will have to change the detector boxes.

Box size -  $\sim 1,5 \times 1,8 \text{ m}^2$   
Material — aluminium  
Minimizing material budget near to beam axis

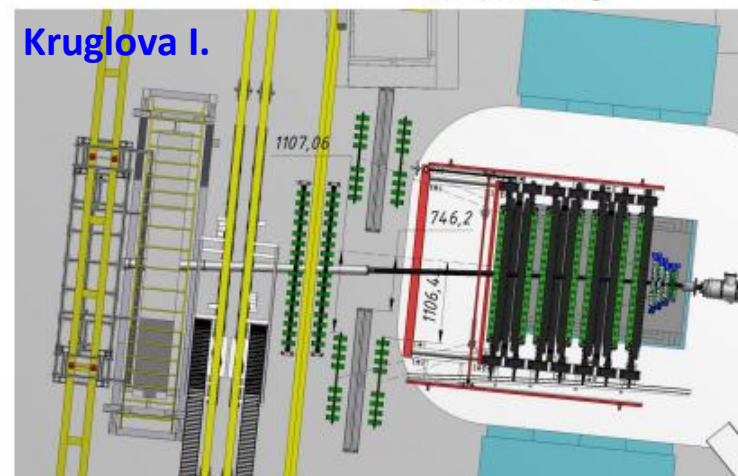
The aluminum box guides are currently fully manufactured

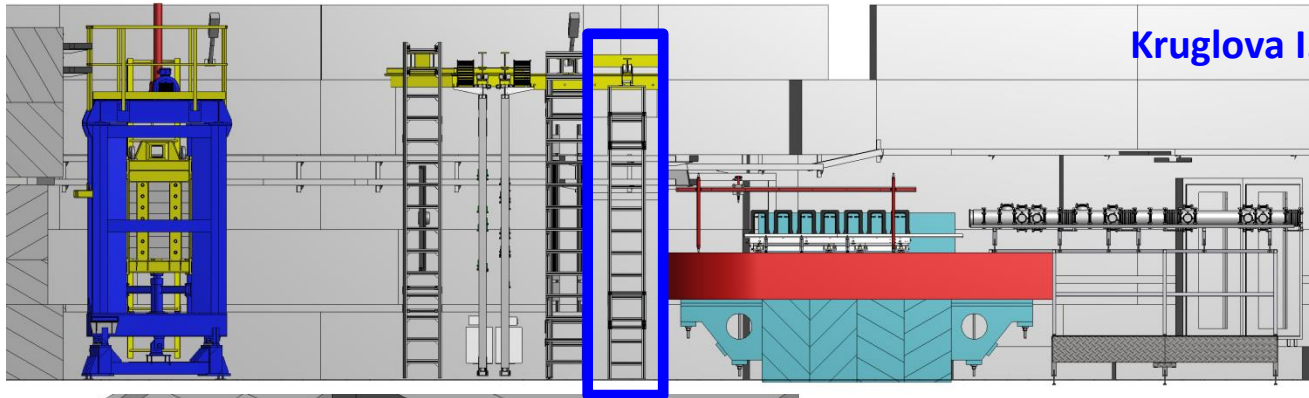
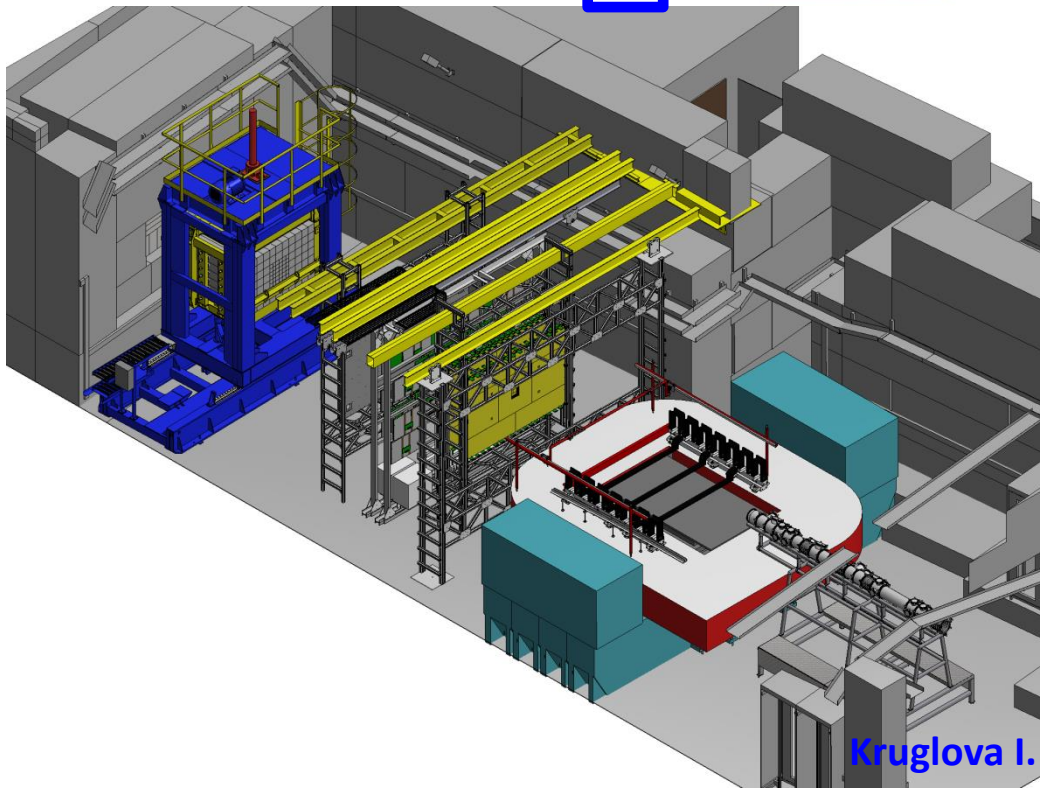
1. Mechanical support materials: **Yes**
2. Supporting structure for mechanical support : **Yes**
3. Brackets for fastening the supporting structure : **Yes**
4. Mechanical Support Project: **Yes**
5. The detector is ready for installation: **No (Modernization now)**

Mechanical support for new ToF400 modules installed in the experimental hall
