Forward Silicon Tracker status

Danil Chemezov on behalf of Forward Silicon Tracker team

Analysis and Detector Meeting of the BM@N Experiment,
12-13 March 2024

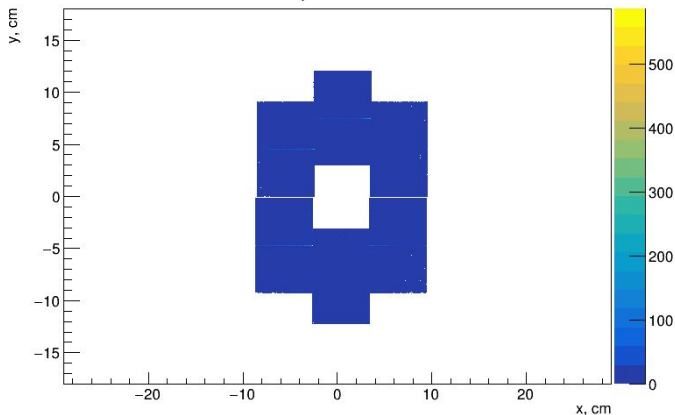
Hits on station 1
6 modules, DSSD 63×93 mm²

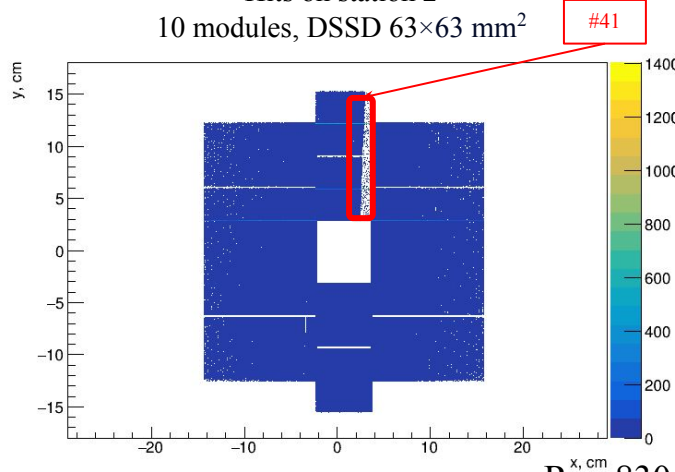
Hits on station 2
10 modules, DSSD 63×63 mm²

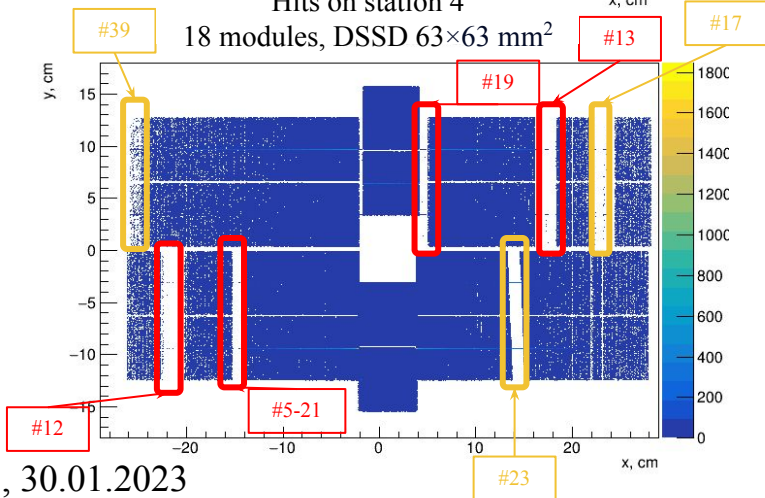
Hits on station 4
18 modules, DSSD 63×63 mm²

Summary:
10 dead zones, 3
were discovered
before the run and
7 occurred during
the run

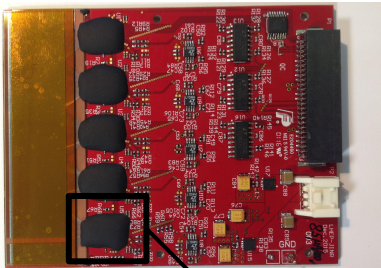
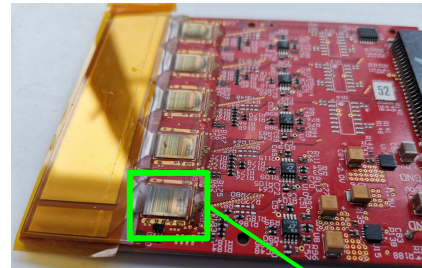
Black BE-08 encapsulant (polarization temperature 100°C)

- an additional optical shield for chips
- **Not removable** mechanically or with chemical solvents (dimethyl sulfoxide, dimethylformamide, CH₂O₂)

Ultra Light-Weld 9008 Flexible, UV-Curable Encapsulant

- Does not create an additional optical shield
- Can be mechanically removed so **FEE boards are repairable**

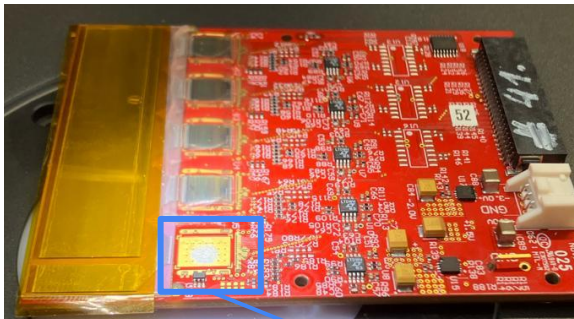
Replacement of one chip:

removed chip

- We get information about problematic modules from Xe-run results;
- Based on test results, we localize the defect: № module, PCB-type (p+ or n+), №chip on PCB;
- For transparent encapsulant: we can replace a single chip without damaging the others;
- For black encapsulant: replace the entire board, because BE-08 encapsulant not removable;
- 30 spare chips available;
- We are testing removed PCBs and trying to determine cause and type of defects for problematic chips

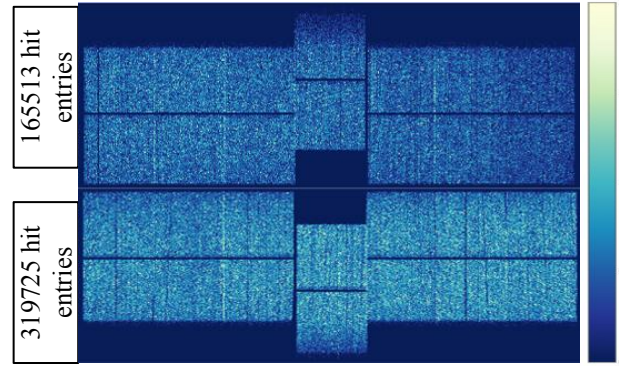
Cosmic tests station 3

All dead zones have been eliminated!
