Status of the GEM and CSC systems

Elena Kulish on behalf of
the GEM and CSC groups

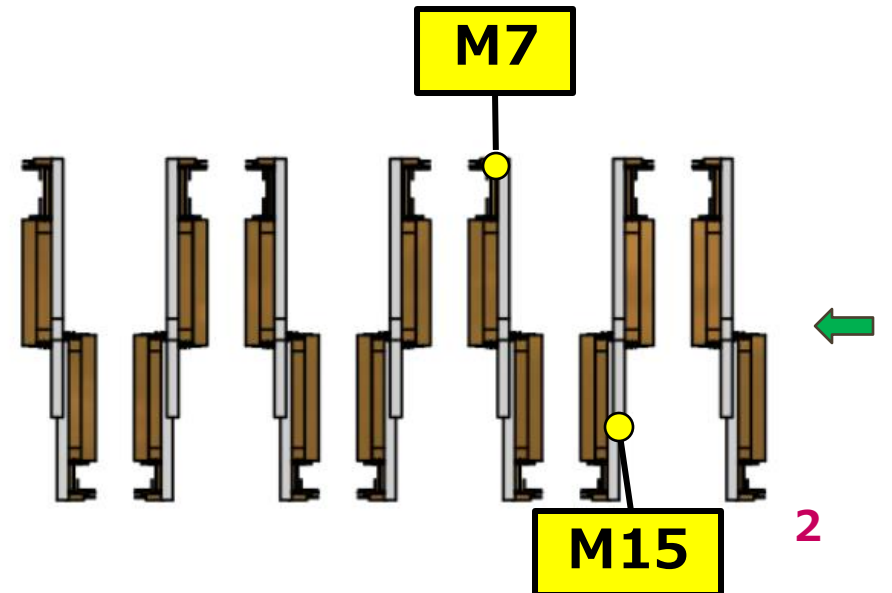
At the end of the Run 8, the detector M15 stopped working normally because the divider leg broke.

The existing divider design is not suitable for repair in the SP-41 magnet. Therefore it was decided to modernize the design of the divider.

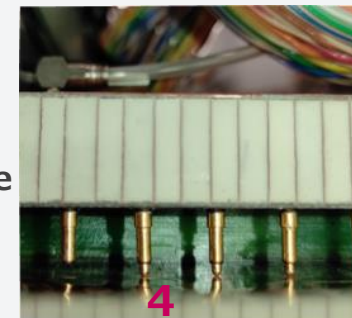
Problems (solved): pins get stuck and do not allow the board to move freely.
